Residential Flashover Prevention with Reduced Water Flow: Phase 1

Daniel Madrzykowski
Nicholas Dow

UL Firefighter Safety Research Institute
Columbia, MD 20145

April 29, 2020

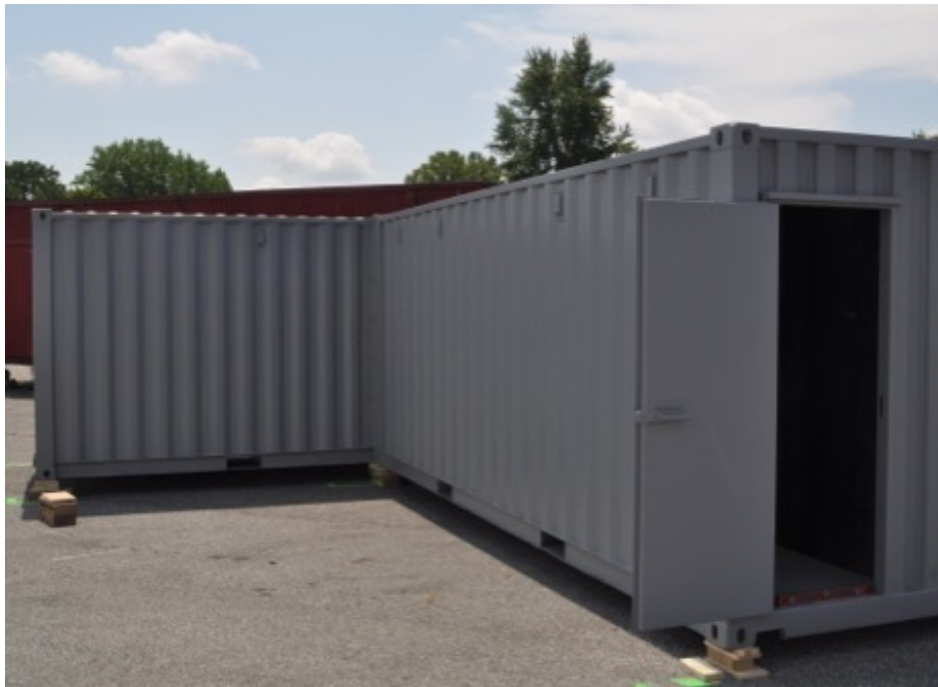
Figure 3.1: Exterior view of the test structure.

Two exterior openings were present in the test structure. One opening was the doorway serving as the entrance to the structure, at the opposite end of the hallway from the fire room. It remained open during all of the experiments. The dimensions of the doorway were 0.8 m (2.5 ft) wide by 2.0 m (6.7 ft) tall. The second opening was a ventilation duct through the window in the fire room, whose purpose was to supply fresh air to the seat of the fire. The remaining area of the window was sealed shut during all of the experiments. The ventilation duct had a constant cross-sectional area with dimensions of 0.7 m (26 in) by 0.2 m (8 in). The opening of the ventilation duct in the interior of the structure was 0.3 m (1 ft) above the floor of the fire room and parallel to the floor. Its position within the fire room is provided by Figure 3.2, and it is pictured in the background in Figures 3.4 and 3.5.

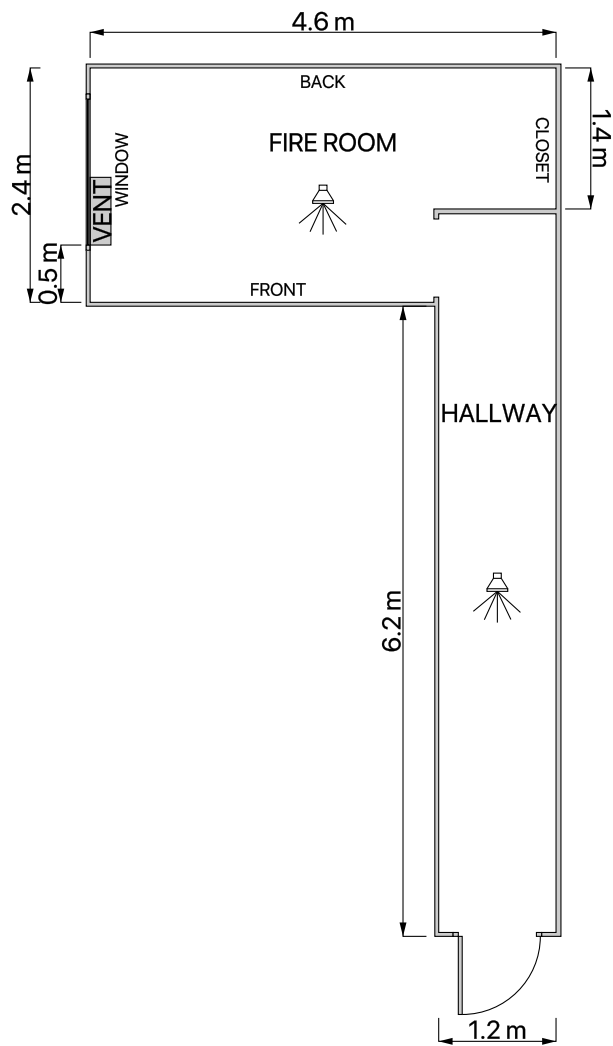
Figure 3.2: Plan view of the test structure including major dimensions.

Ports for the water sprays were installed in both the hallway and the fire room, centered in each room. These locations are pictured in the floor plan in Figure 3.2. The water spray nozzles were installed such that the base was flush with the ceiling, and the orifice was approximately 4.0 cm (1.6 in) below the ceiling. Figure 3.7 shows a nozzle and the sprinkler as they were installed in the test structure.

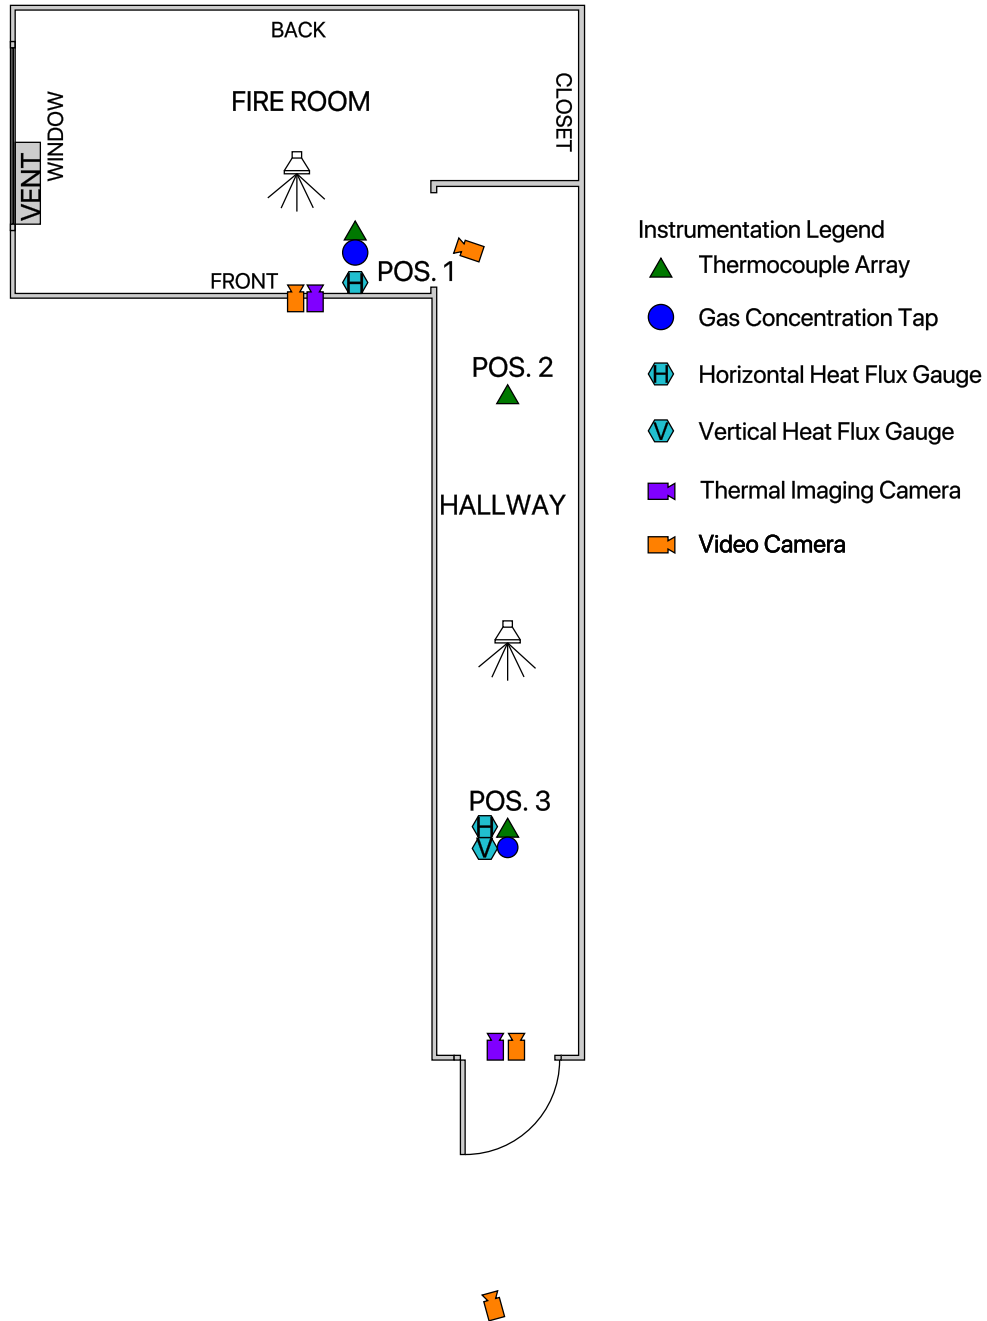
Figure 3.3: Instrumentation locations in the test structure.

For the propane burner experiments the flow of propane was controlled and measured with a mass flow meter which was installed in-line between the propane tanks and the burner. Standard video and fire service thermal imaging cameras were installed inside of the structure to capture infor-

mation about the fire dynamics of the experiments. To ensure video capture even if the cameras experience thermal failure, the cameras were hardwired to a digital video recorder that was outside of the structure. The positioning of the cameras is shown in Figure 3.3. The camera installed in the front wall of the fire room was not included in the propane burner experiments.

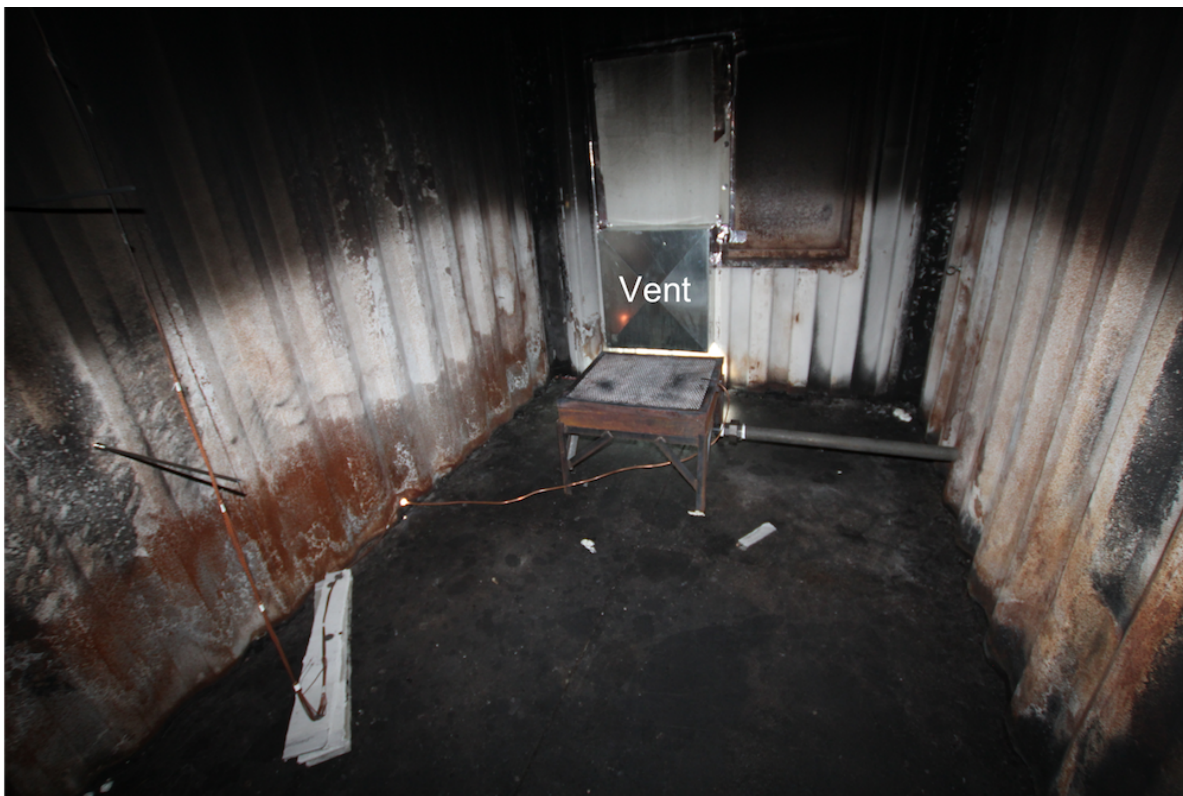
Figure 3.4: Photograph of propane burner installed in the fire room.

A propane burner was used as the fire source in the gas cooling experiments. The burner had a square opening on its top face, with dimensions of 0.6 m (2.0 ft) by 0.6 m (2.0 ft). The height of the opening from the floor was 0.5 m (20 in). The burner was positioned in the fire room so that its center was 1.0 m (3.4 ft) from the window wall and 1.4 m (4.5 ft) from the back wall. Figure 3.4 shows the burner as it was installed during the experiments.

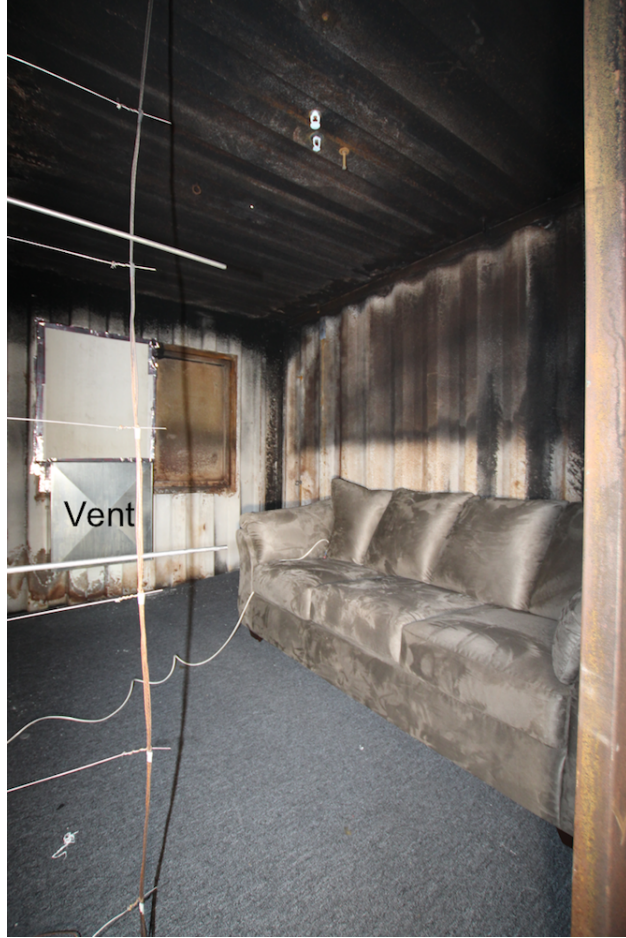
Figure 3.5: Photograph of fire room with furnishings installed.

The fuels used in the furnished room experiments have been characterized in terms of heat release rate (HRR). Upholstered sofas, similar to those used in the furnished room experiments, were characterized as part of ongoing work funded by the National Institute of Justice. They were burned under the UL oxygen consumption calorimeter in Northbrook, IL to determine the HRR and the total heat released. Three replicate sofa HRR experiments were conducted. The HRR experiments were conducted in a free burn condition without any compartmentation effects. Table 3.1 shows the peak HRR and total heat released for each sofa and Figure 3.6 shows HRR time history for each sofa. The components of the flooring were burned under a lab scale cone calorimeter. Table 3.2 summarizes the data collected with the cone calorimeter for the flooring components. The cone calorimeter data demonstrates that if the flooring, padding, or carpeting under the sofa burned due to being shielded from the water, a significant HRR could be produced.

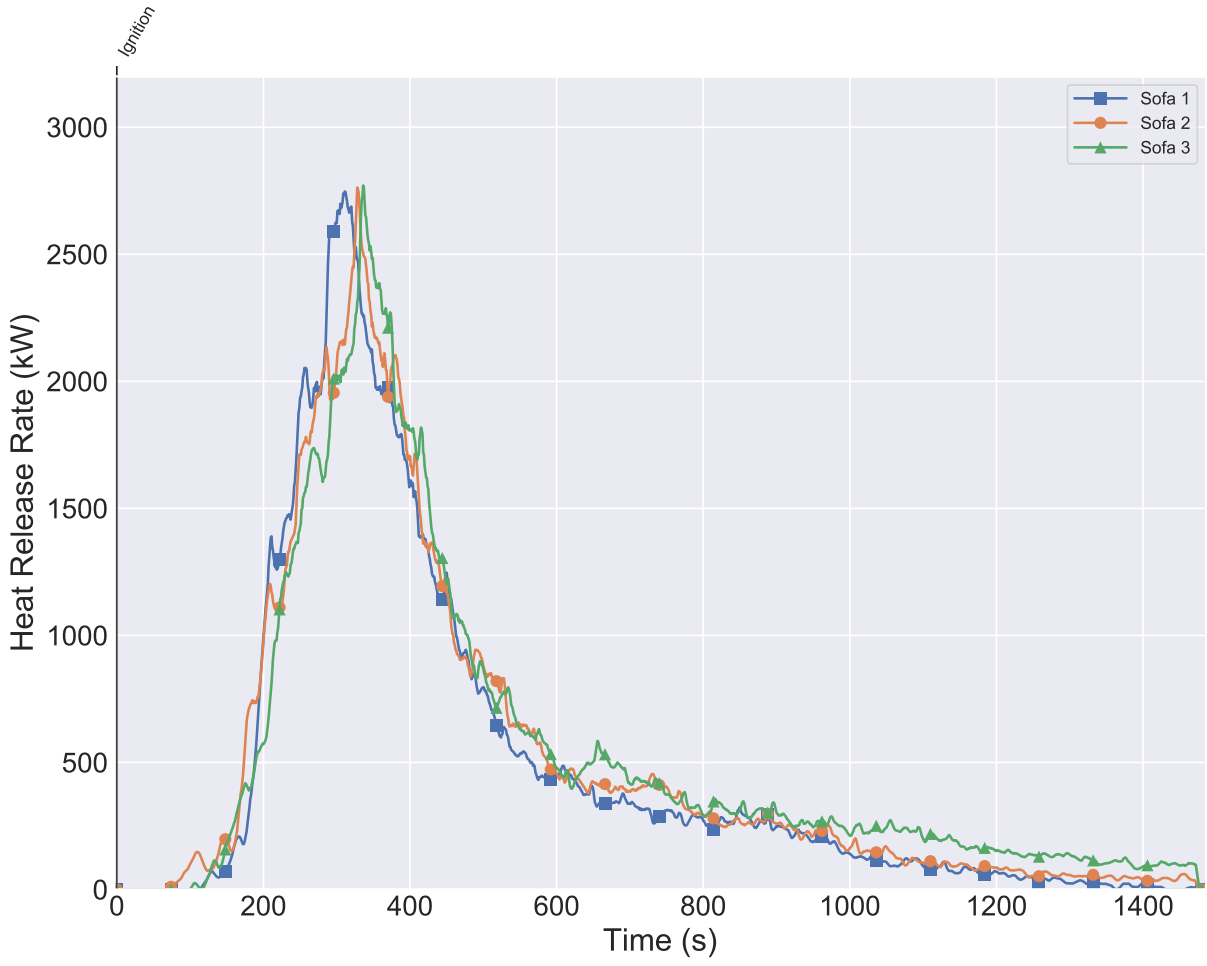
Figure 3.6: Three replicate HRR time histories of the sofas used in the furnished room experiments.

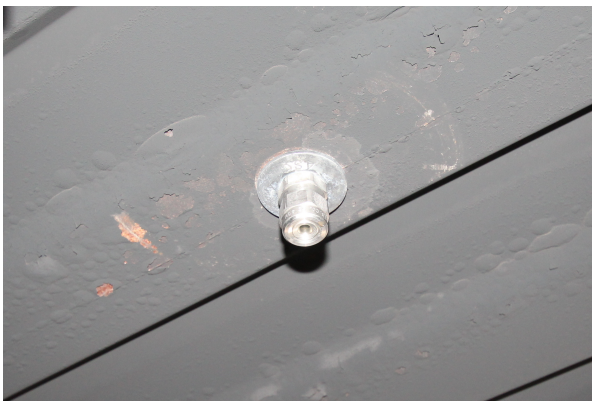
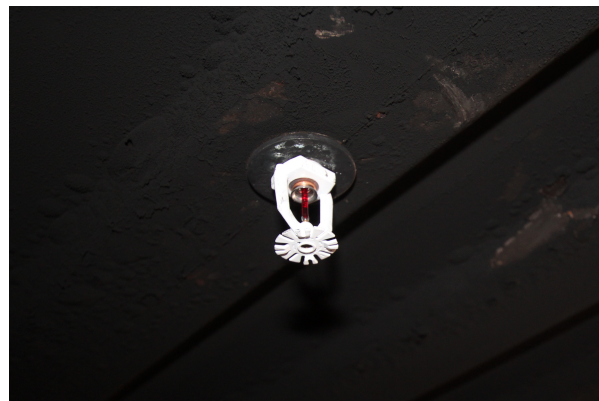
(a) Spray Nozzle

(b) Residential Pendent Sprinkler

Figure 3.7: Photographs of water sprays installed in the test structure.

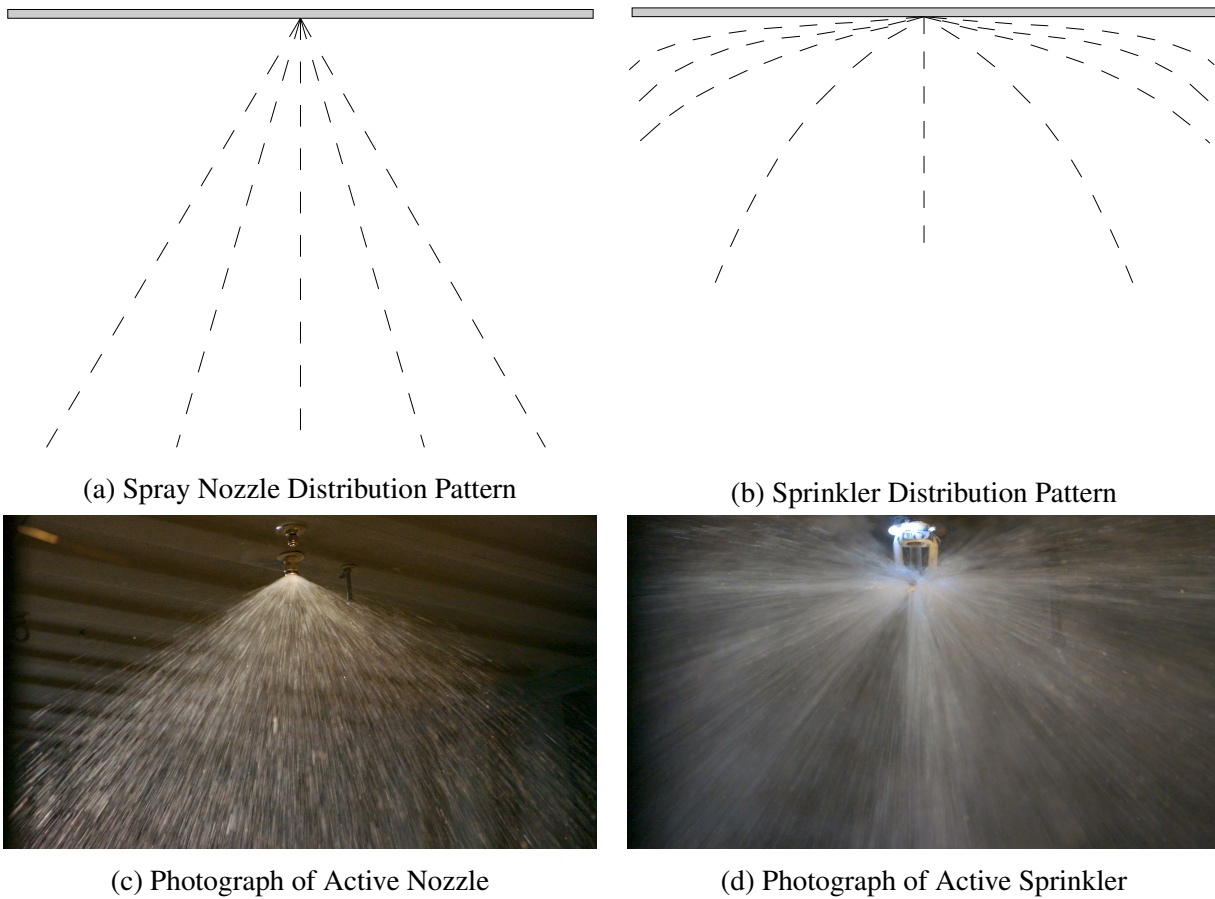
Figure 3.8: Comparison of the spray patterns for nozzles vs. sprinklers.

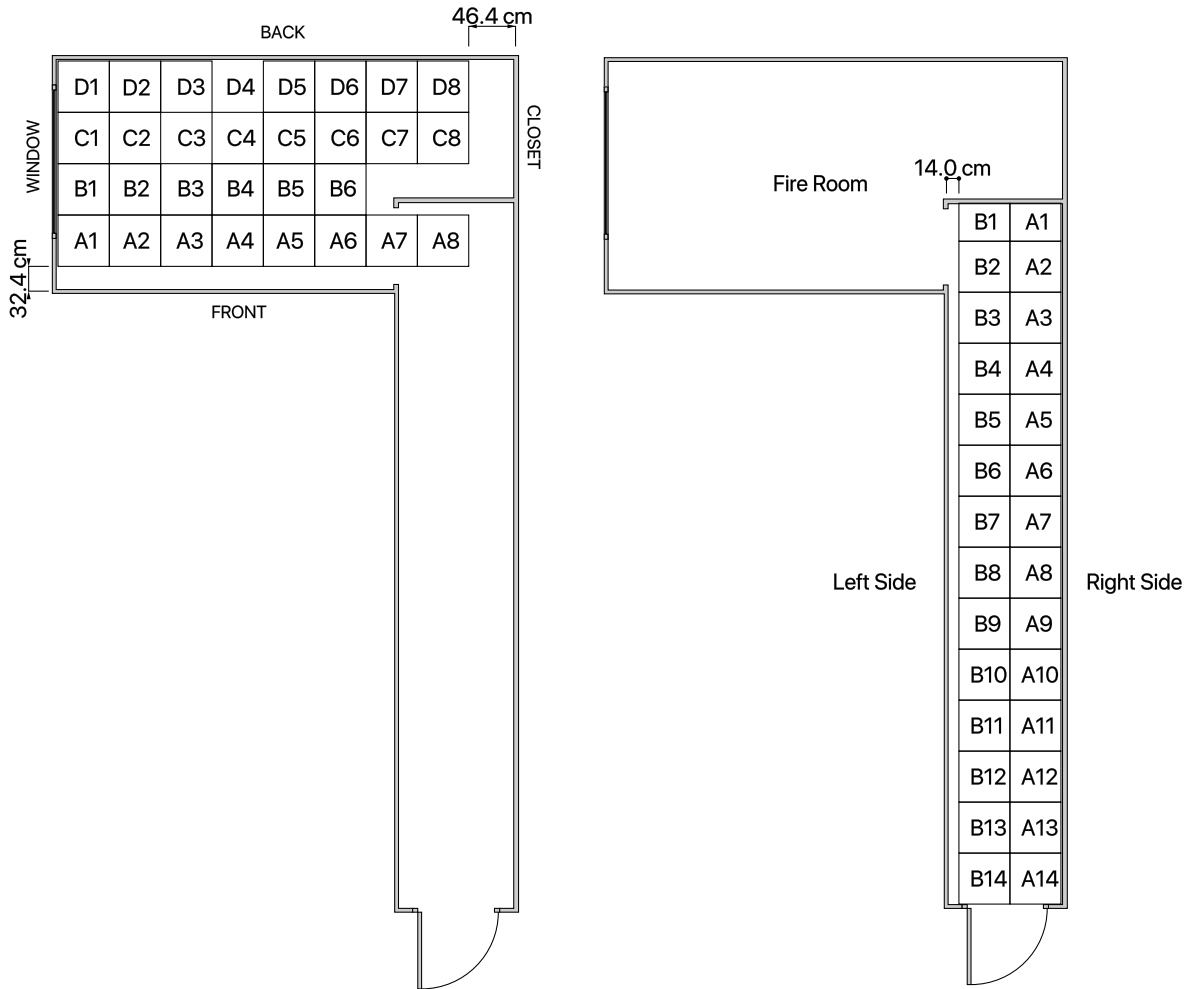
(a) Fire Room Tests

(b) Hallway Tests

The water distribution was determined by measuring the mass of the water collected in each bucket and the duration of the water flow. The duration of each test was 5 minutes. From these values the water flow rate per unit area, *water flux*, was calculated. The water flux was calculated for each bin, and averaged over each replicate. The results are visualized by Figures 3.10 and 3.11. In

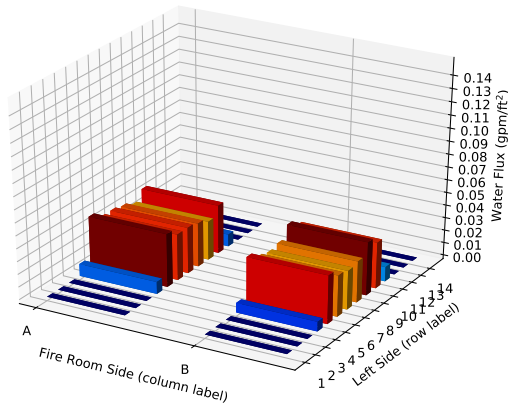
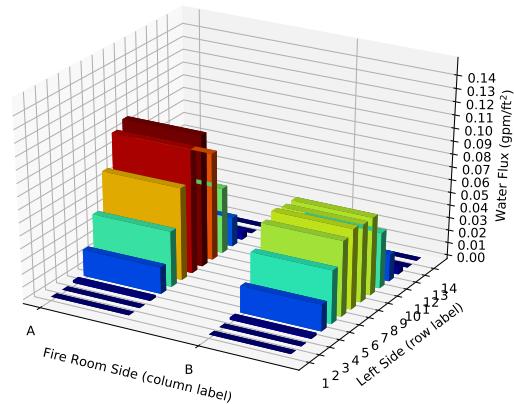
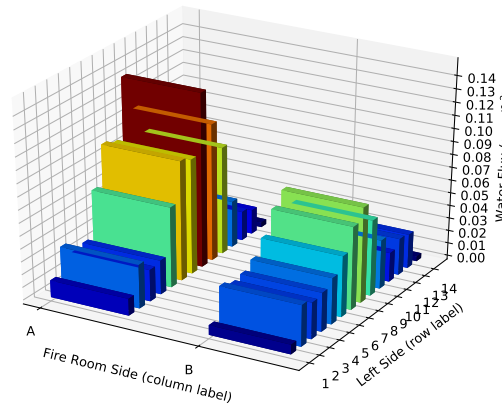
(a) Medium Capacity Nozzle; 11 lpm (3 gpm)

(b) Medium Capacity Nozzle; 23 lpm (6 gpm)

(c) Sprinkler; 34 lpm (9 gpm)

In the hallway, the water distribution patterns of the medium capacity nozzle at 23 lpm (6 gpm) and of the sprinkler were bell-shaped along the length of the hallway. Figures 3.10b and 3.10c show that the peak water flux was measured nearest to the water spray, and tapered off further

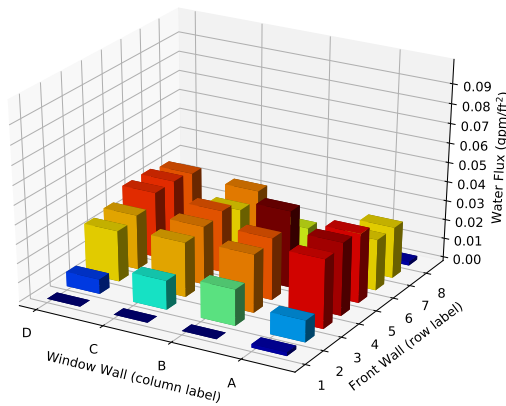
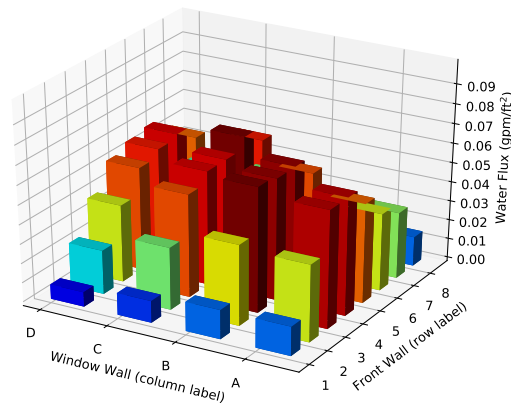
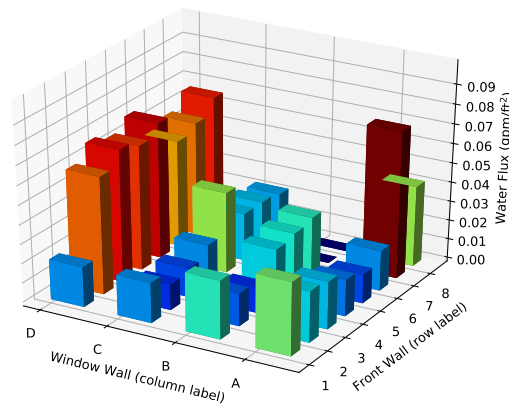
(a) Medium Capacity Nozzle; 11 lpm (3 gpm)

(b) Medium Capacity Nozzle; 23 lpm (6 gpm)

(c) Sprinkler; 34 lpm (9 gpm)

In the fire room, the difference between the distribution patterns of the nozzle and of sprinkler are evident. The nozzle is designed to provide an evenly distributed cone pattern, which can be seen

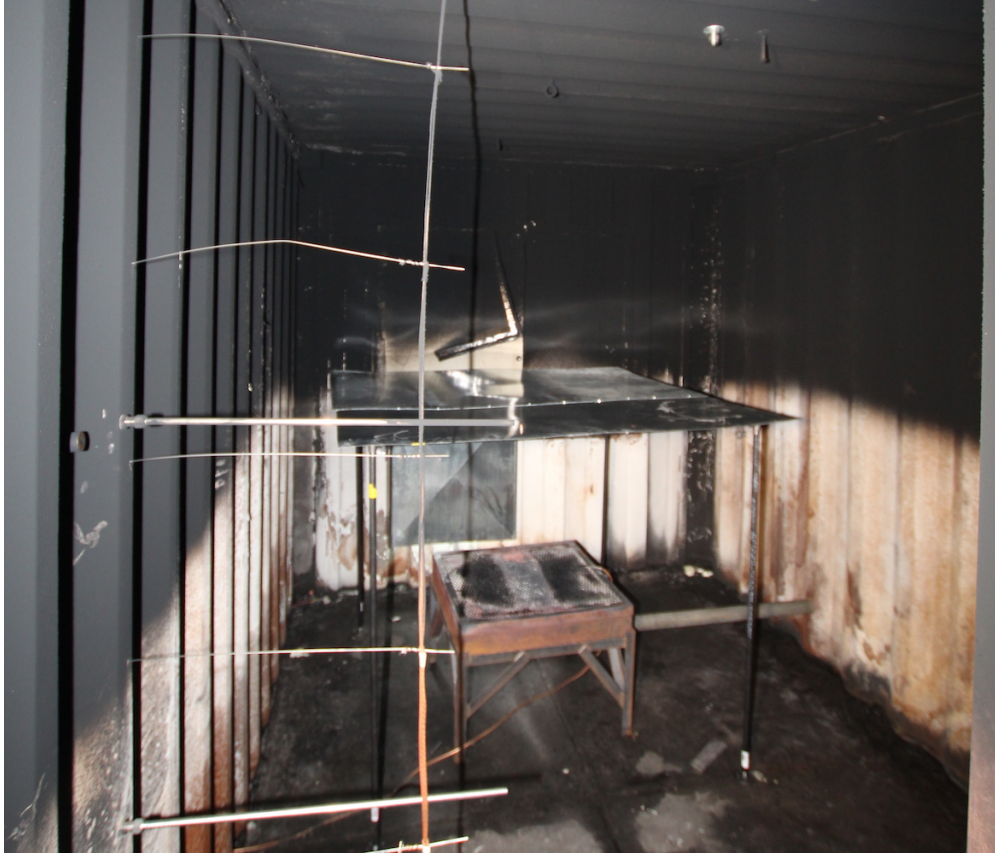
Figure 4.1: Photograph of the shielded burner.

The test procedure for the propane burner experiments was as follows. At least 60 seconds of background data was collected prior to igniting the burner, and the video recording was started. Two minutes were spent after ignition to allow the hot gas layer flow to reach steady-state. Once two minutes had passed, the water spray was activated. Water was discharged for another two minutes to reach new steady conditions. Then the water spray was turned off for two minutes to allow the hot gas layer flow to return to the original steady-state. This cycle, two minutes of water off / two minutes of water on, was repeated for three replicates. After the final replicate, the water and burner flows were turned off and the structure was provided time to cool down to ambient temperatures while the next test configuration was prepared. For the tests with the water spray activated in the fire room, the burner was shielded from the water, as shown in Figure 4.1.

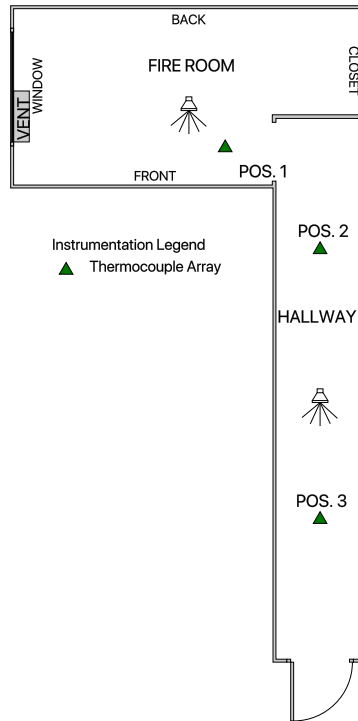
Figure 5.1: Instrumentation locations in the test structure.

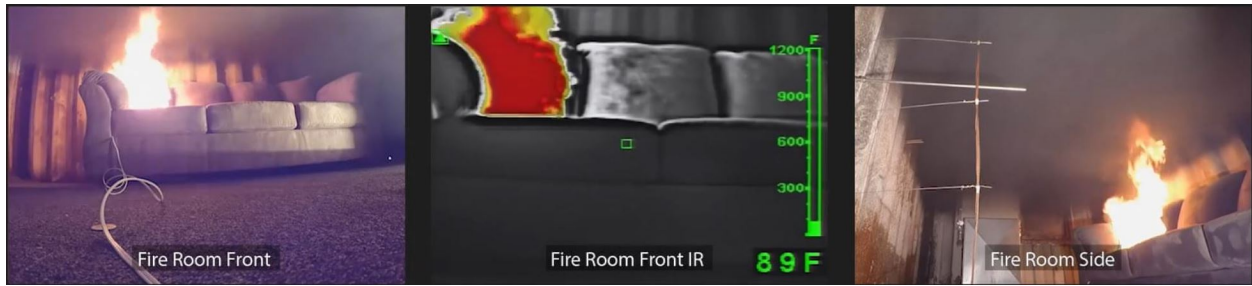
Figure 5.2: Experiment 1 - Conditions in the fire room at 150 s, just prior to sprinkler activation.

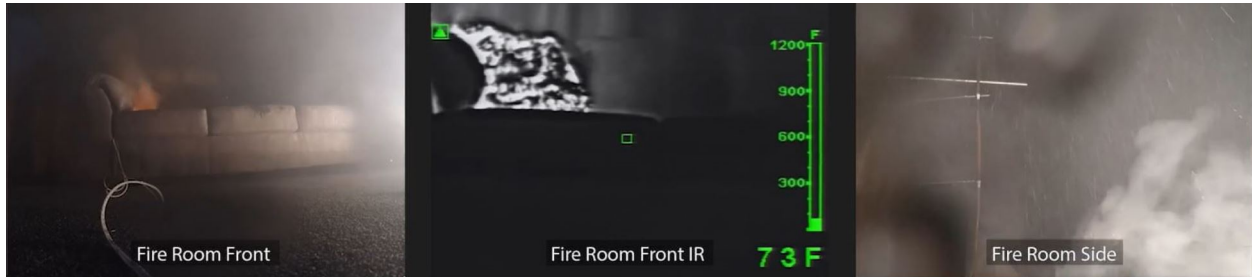
Figure 5.3: Experiment 1 - Conditions in the fire room at 180 s, 30 s after sprinkler activation.

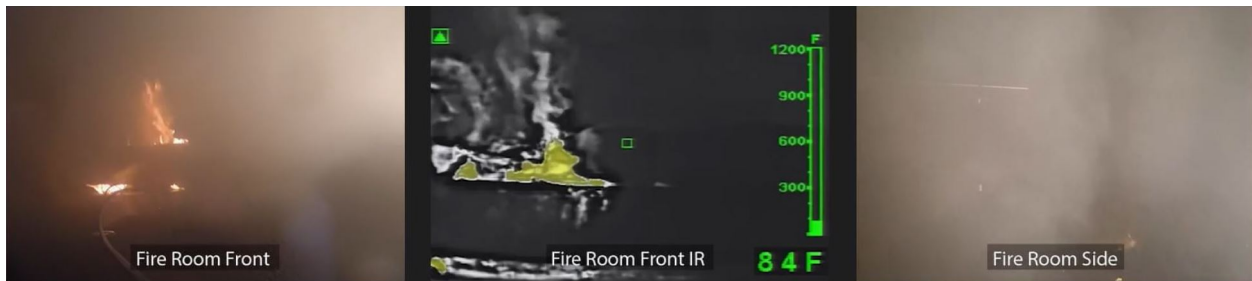
Figure 5.4: Experiment 1 - Conditions in the fire room at 750 s, or 10 minutes after sprinkler activation.

terminated based on the general 10 minute water supply requirement in NFPA 13D [1]. Figure 5.4 shows the video and thermal imaging views of the fire room 10 minutes after sprinkler activation to provide a sense of the fire conditions at that time.

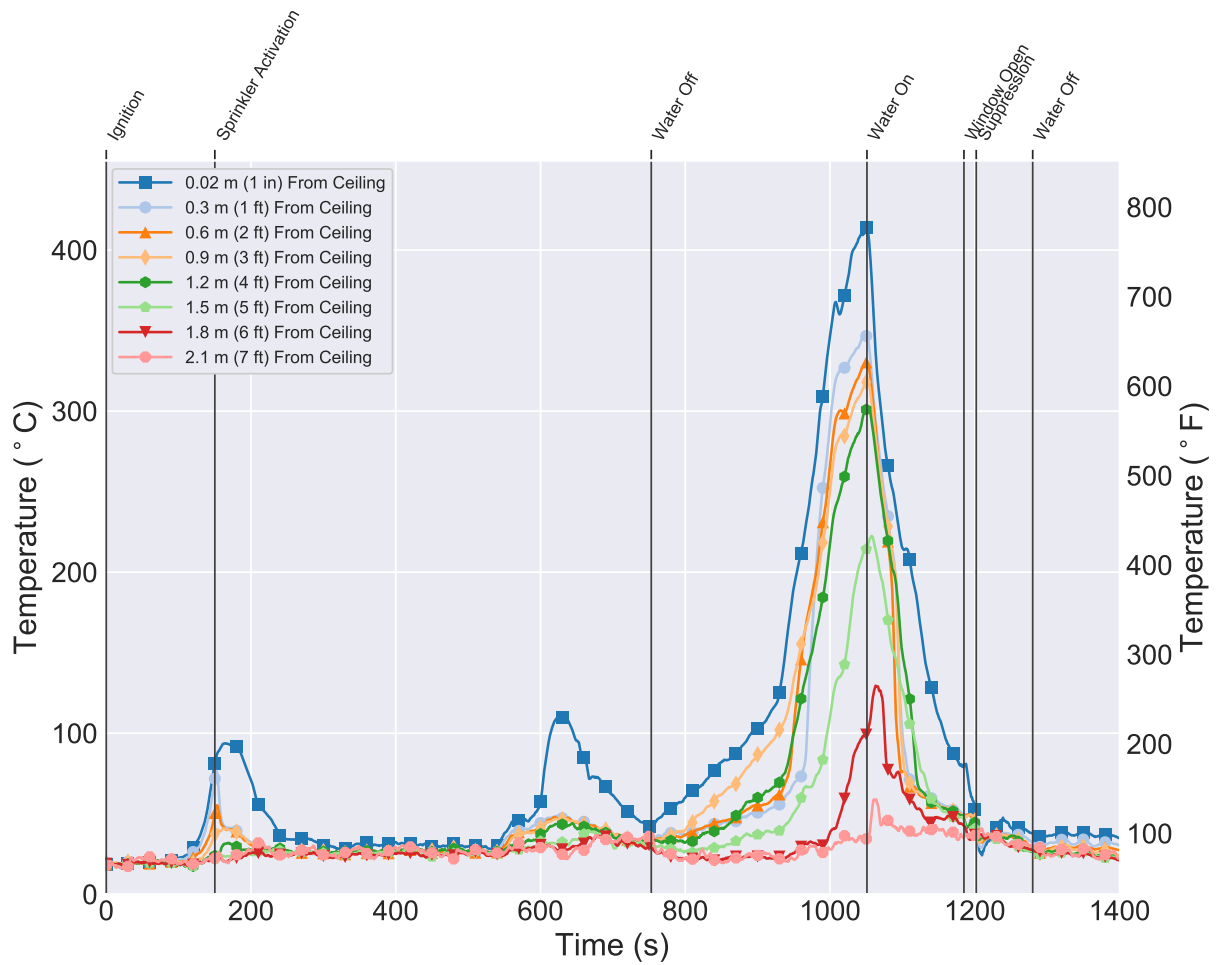
Figure 5.5: Experiment 1 - Thermocouple temperature time history from the thermocouple array in the fire room (Position 1).

After the sprinkler was turned off temperatures in the fire room began to increase as shown in Figure 5.5. This third growth phase reached a peak temperature in the fire room of more than 400 °C and a peak heat flux of approximately 23 kW/m², measured at Position 1. About 5 minutes after turning off the water to the sprinkler, the water to the sprinkler was turned on again to knock down the fire. At 1185 seconds after ignition, the window to the fire room was opened and the fire was extinguished by hose suppression, concluding the experiment.

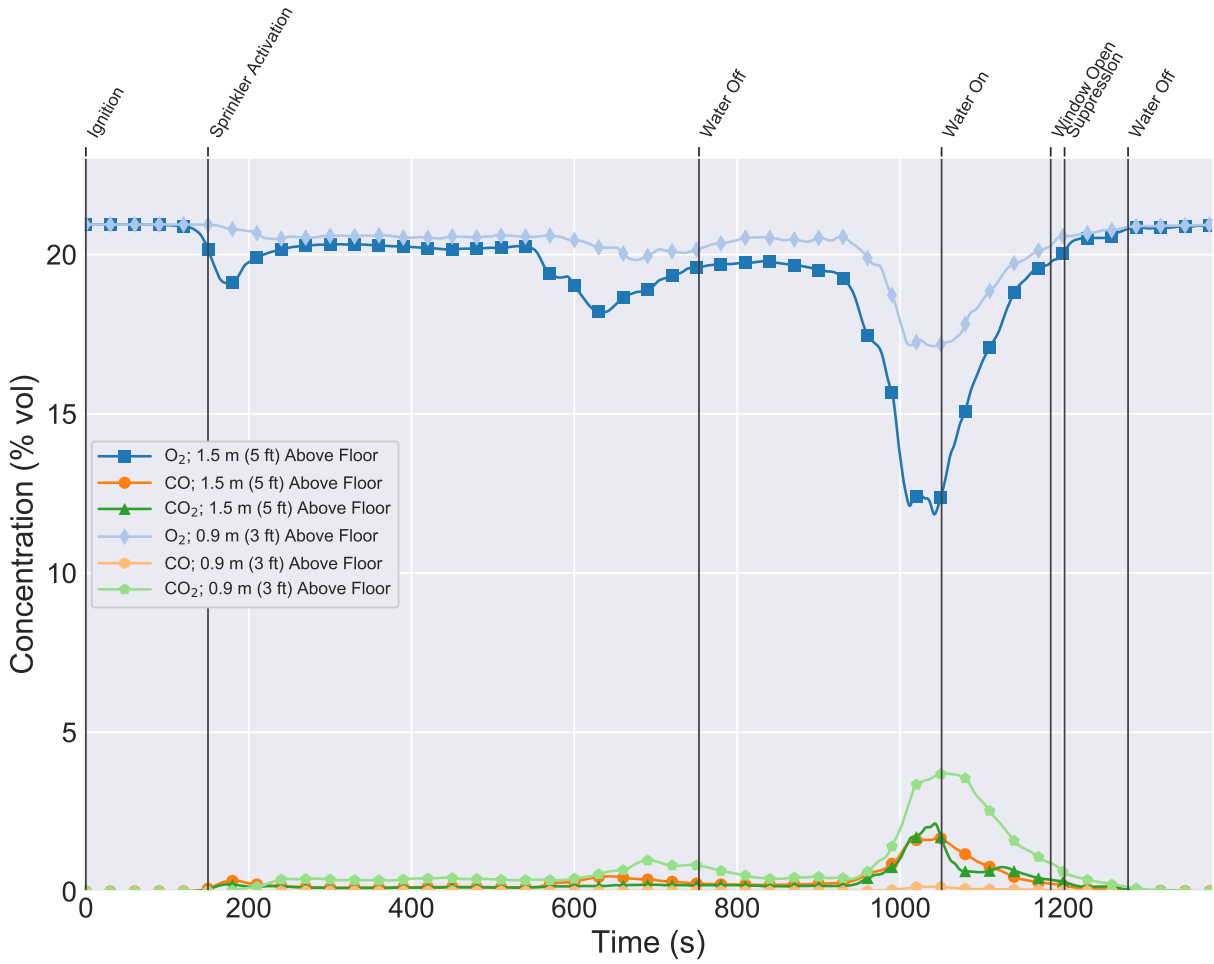
Figure 5.6: Experiment 1 - Gas concentrations time history measured in the fire room (Position 1).

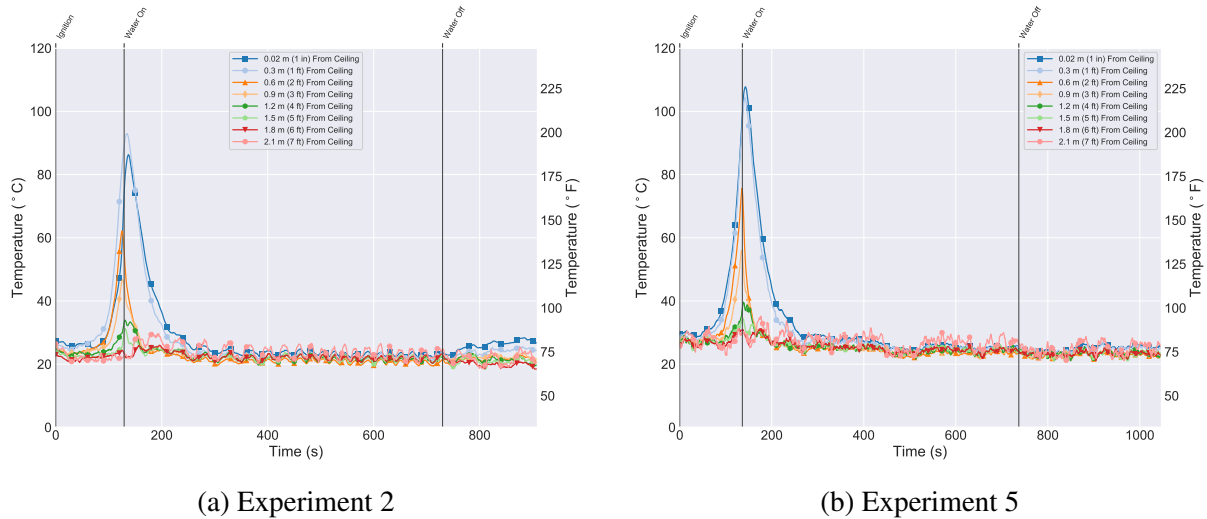
Figure 5.7: Experiments 2 and 5 - Thermocouple temperature time history from the thermocouple array in the fire room (Position 1).

Experiments 2 and 5 were replicates, where the medium capacity nozzle was installed in the fire room and set to flow water at 23 lpm (6 gpm). The fuel load was the same as in Experiment 1. The time history of the temperature profile and gas concentrations at Position 1 in the fire room are shown in Figures 5.7 and 5.8, respectively.

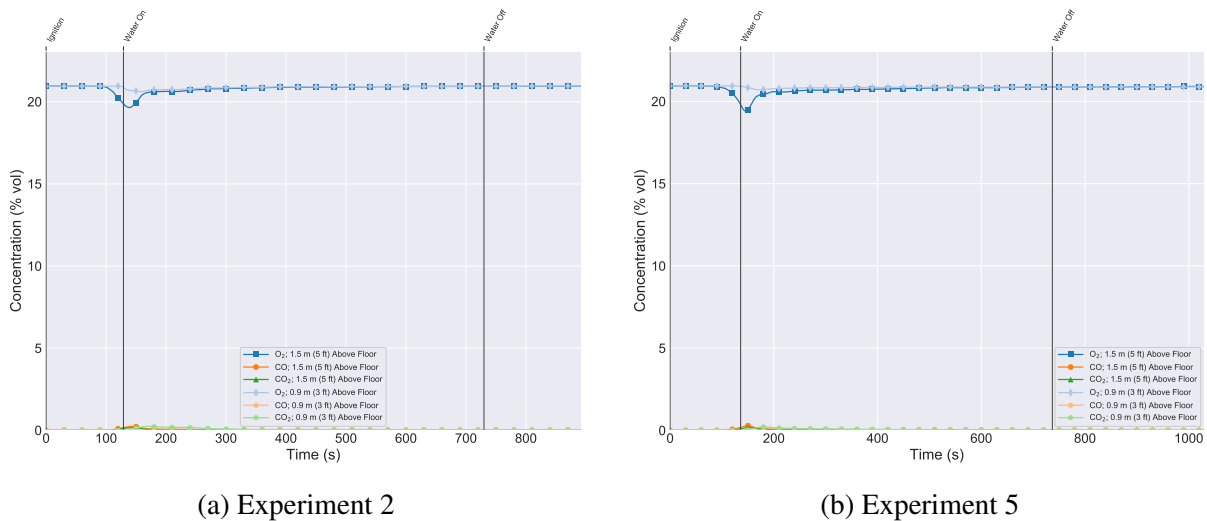
Figure 5.8: Experiments 2 and 5 - Gas concentrations time history measured in the fire room (Position 1).

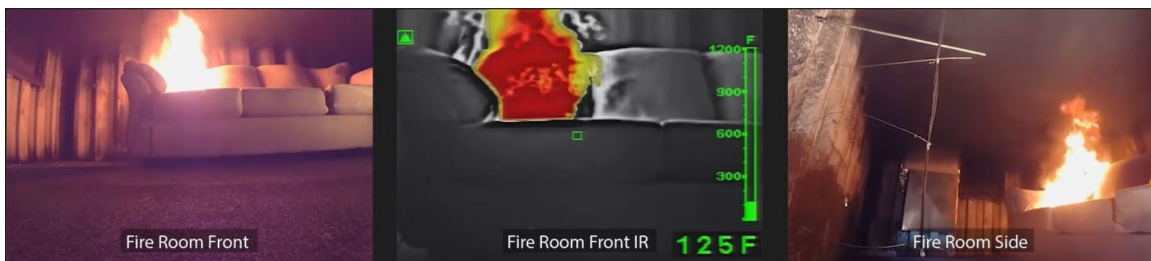
Figure 5.9: Experiment 5 - Conditions in the fire room at 135 s, just prior to nozzle activation.

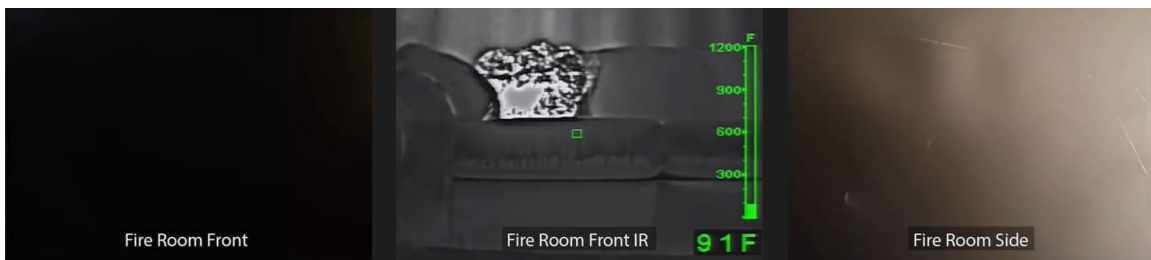
Figure 5.10: Experiment 5 - Conditions in the fire room at 165 s, 30 s after nozzle activation.

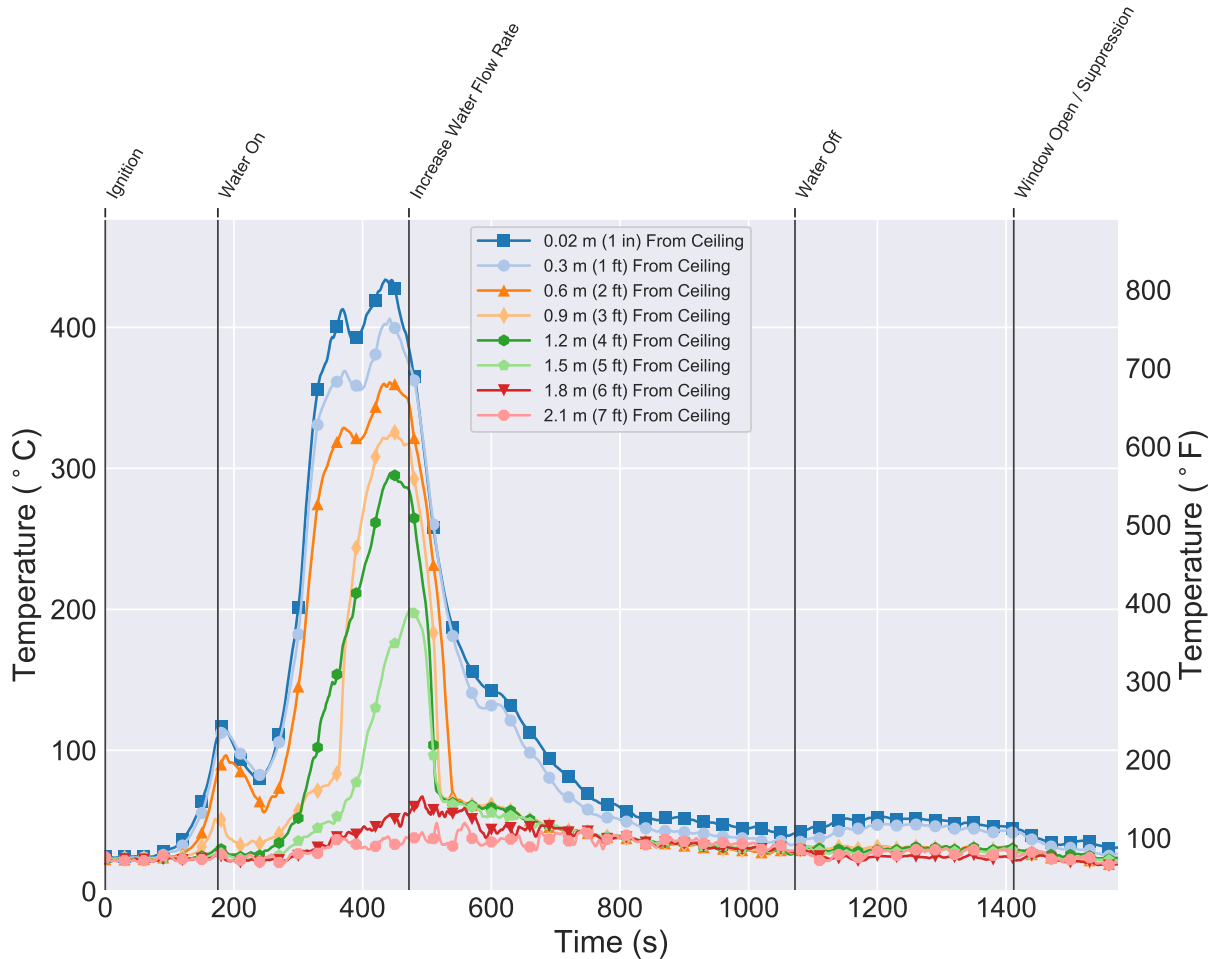
Figure 5.11: Experiment 3 - Thermocouple temperature time history from the thermocouple array in the fire room (Position 1).

Experiment 3 involved the same scenario as Experiments 2 and 5, but with a lower water flow rate of 11 lpm (3 gpm). The medium capacity nozzle was installed in the fire room which was prepared with carpet flooring and a sofa. The sofa was against the back wall and centered to the nozzle. The time history of the temperature profile and gas concentrations at Position 1 in the fire room are shown in Figures 5.11 and 5.12, respectively.

After ignition, the fire grew for 175 seconds before the nozzle was activated. Immediately prior to nozzle activation, the temperature 2.54 cm (1 in) from the ceiling in the fire room was 112 °C. Following nozzle activation the thermal conditions in the structure cooled for 64 seconds, reaching a local minimum. At the local minimum the temperature at Position 1, 2.54 cm (1 in) from the ceiling was 79 °C. Afterwards, the temperatures throughout the structure rose quickly as the nozzle was insufficient to control the growth of the fire. The limits for tenability according to UL 1626 criteria were exceeded at 121 seconds after the nozzle was activated. The ceiling temperature in

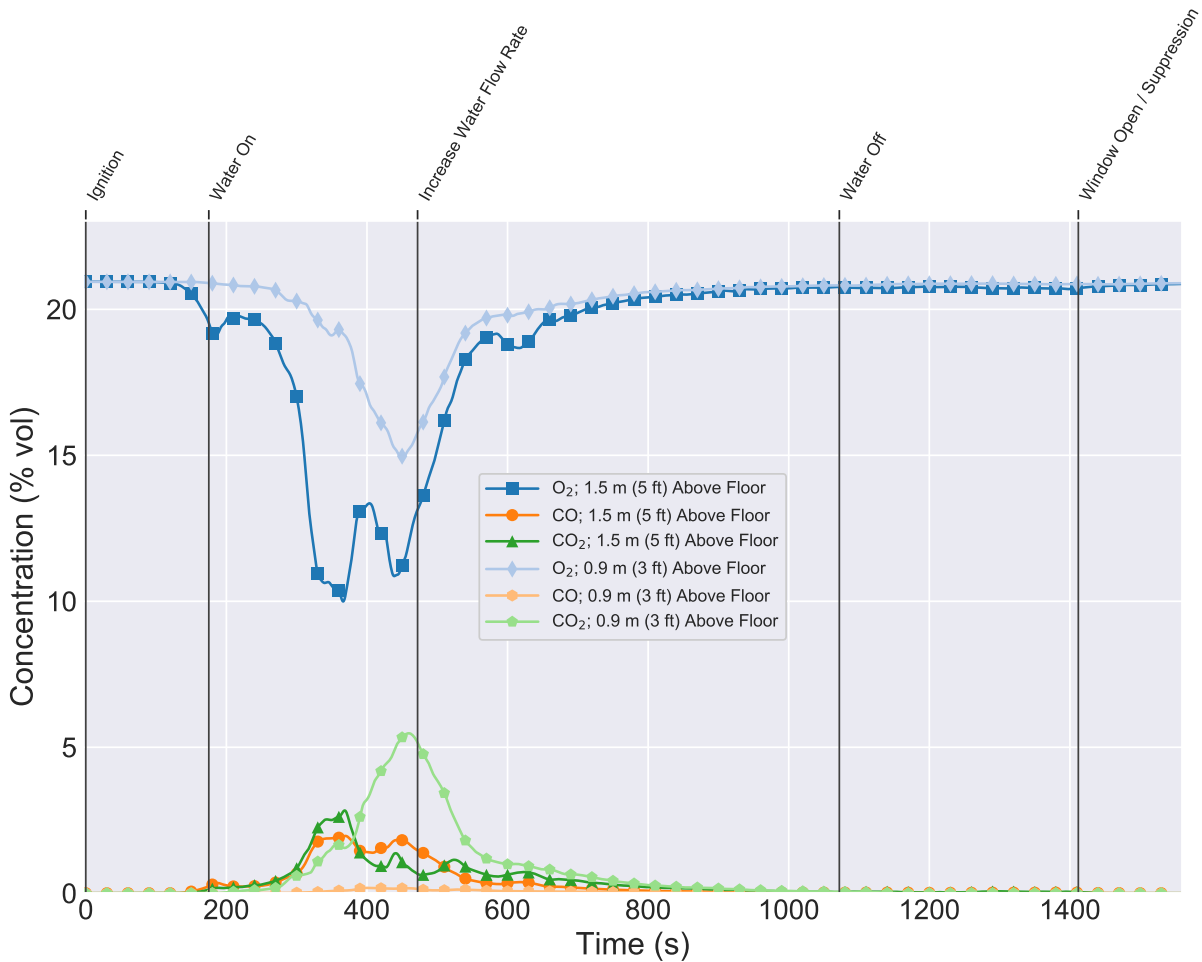
Figure 5.12: Experiment 3 - Gas concentrations time history measured in the fire room (Position 1).

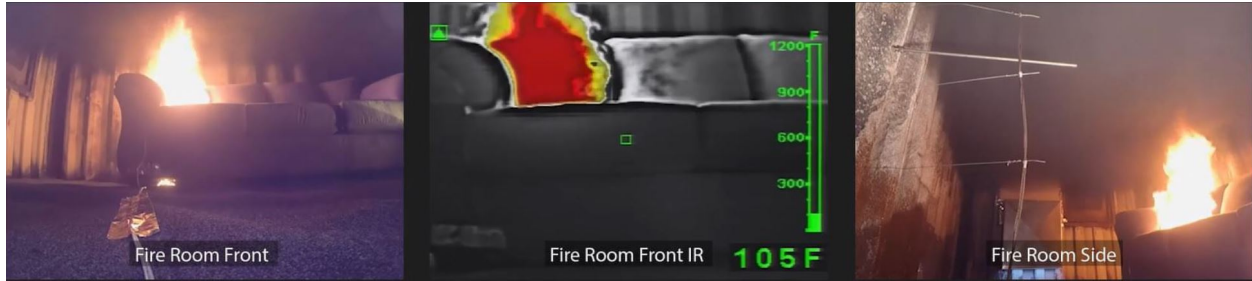
Figure 5.13: Experiment 3 - Conditions in the fire room at 175 s, just prior to nozzle activation.

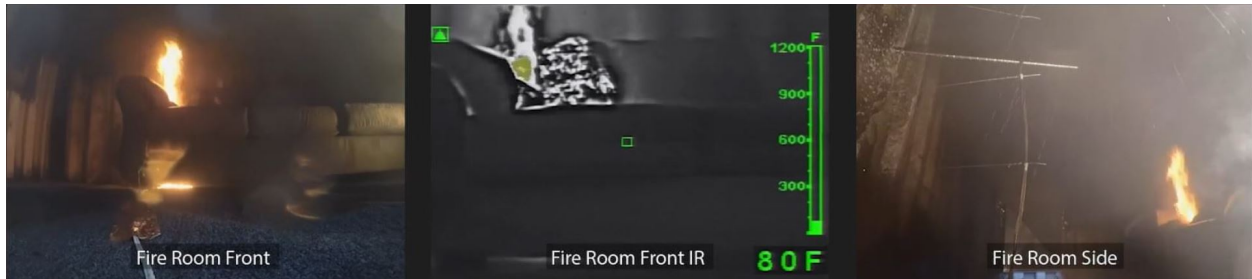
Figure 5.14: Experiment 3 - Conditions in the fire room at 205 s, 30 s after nozzle activation.

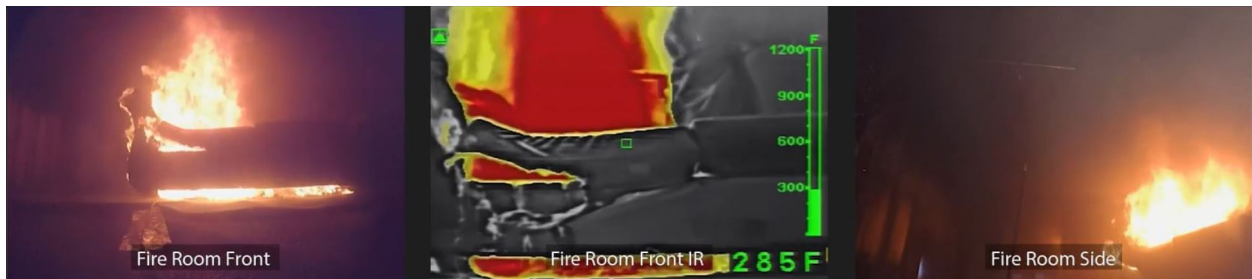
Figure 5.15: Experiment 3 - Conditions in the fire room at 420 s, 30 s before the nozzle water flow was increased.

Upon determining that the water flow rate of 11 lpm (3 gpm) was insufficient to control the fire and maintain tenable temperatures, the flow rate was increased to 23 lpm (6 gpm). The flow rate adjustment occurred approximately 5 minutes after the nozzle was initially activated. At the time when the flow rate was increased to 23 lpm (6 gpm), the fire was larger than the fires in Experiments 2 and 5, but were otherwise similar in configuration. The maximum temperature and heat flux measurements mentioned previously provide a characterization of the fire’s size, and enough fuel remained to allow continued fire growth. Despite the challenge of a larger fire, the flow rate adjustment to 23 lpm (6 gpm) controlled the fire. Temperatures throughout the structure
