Residential Flashover Prevention with Reduced Water Flow: Phase 1

Daniel Madrzykowski
Nicholas Dow

UL Firefighter Safety Research Institute
Columbia, MD 20145

April 29, 2020

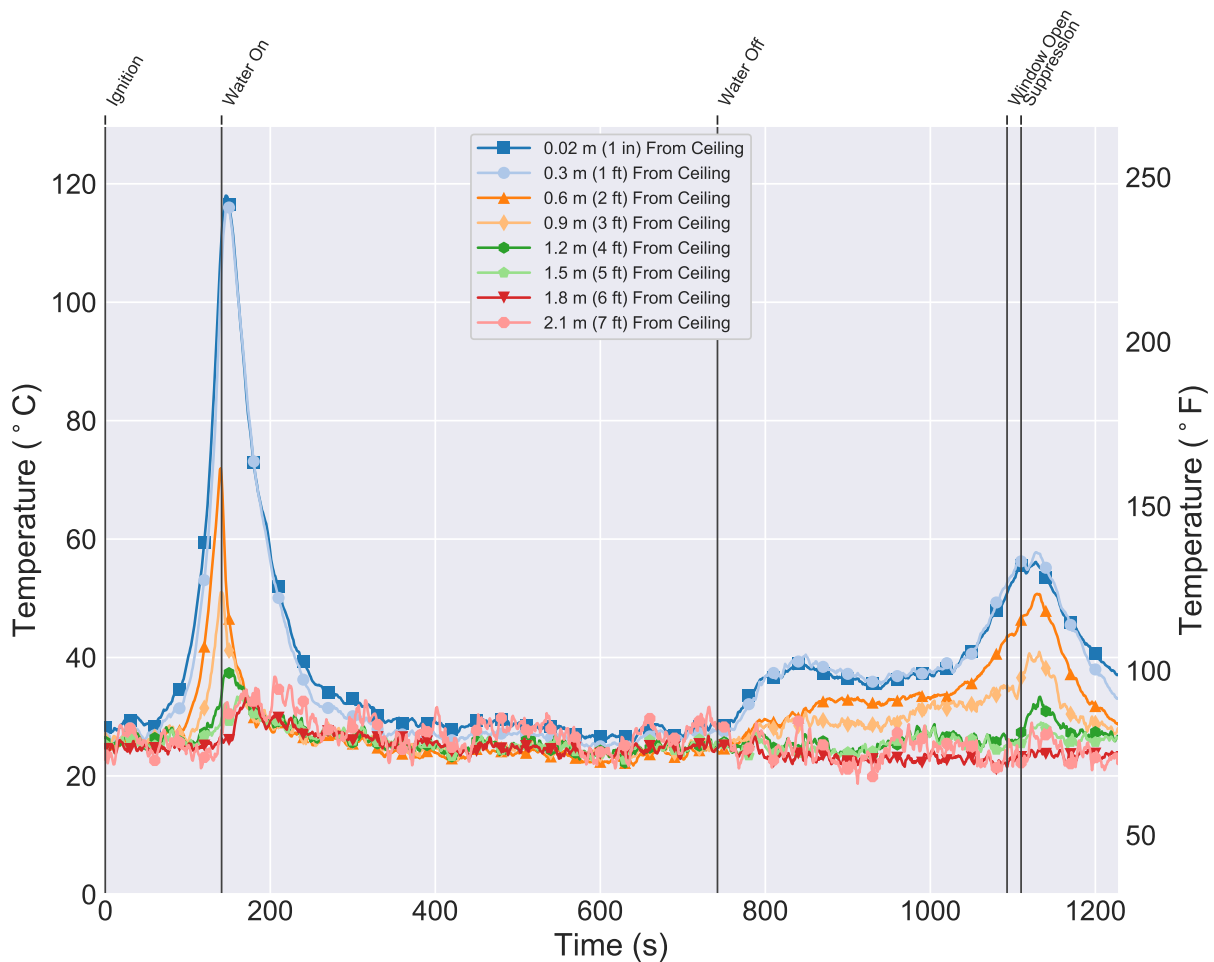
Figure 5.16: Experiment 4 - Thermocouple temperature time history from the thermocouple array in the fire room (Position 1).

Experiment 4 involved the same scenario as in Experiments 2 and 5, but with the sofa moved further away from the nozzle. The back of the sofa was against the back wall of the fire room, and the left arm of the sofa was against the window wall. In the other experiments, the sofa was against the back wall of the fire room, but centered to the water spray. The ignition location was 1.0 m (3.2 ft) further away from the water spray in Experiment 4 than in the other experiments. Like the other experiments, the sofa was ignited by an electric match placed between the left arm and the left seat cushion of the sofa. The water flow rate was 23 lpm (6 gpm). The time history of the temperature profile and gas concentrations at Position 1 in the fire room are shown in Figures 5.16 and 5.17, respectively.

The nozzle was activated 141 seconds after ignition. The temperature 2.54 cm (1 in) from the ceiling in the fire room was 111 °C immediately prior to nozzle activation. The fire was knocked down, but video shows that some burning continued behind and underneath the sofa where it was

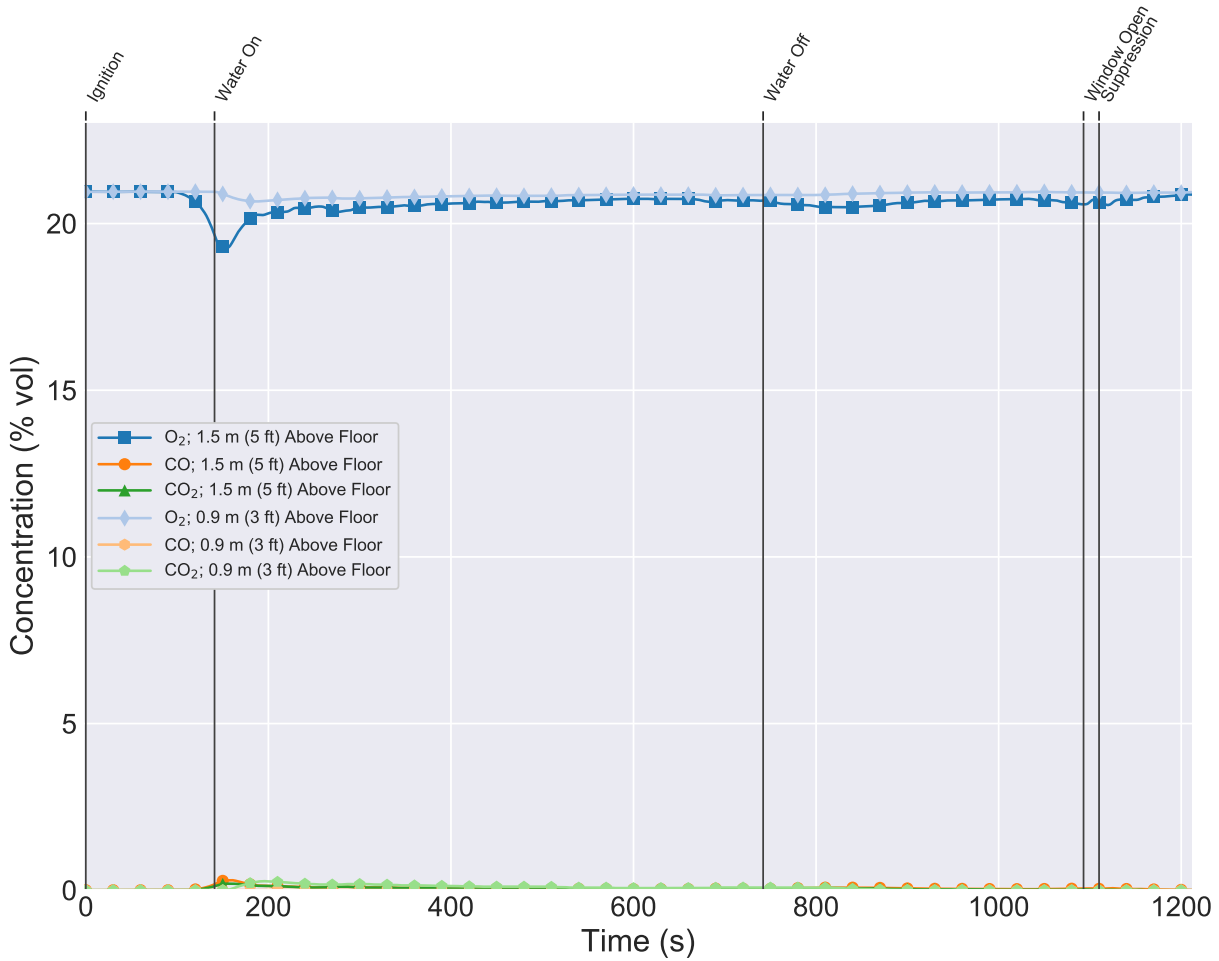
Figure 5.17: Experiment 4 - Gas concentrations time history measured in the fire room (Position 1).

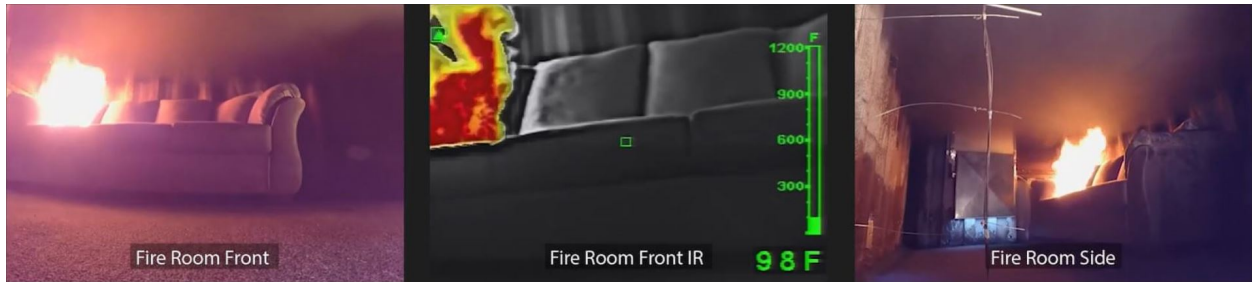
Figure 5.18: Experiment 4 - Conditions in the fire room at 135 s, just prior to nozzle activation.

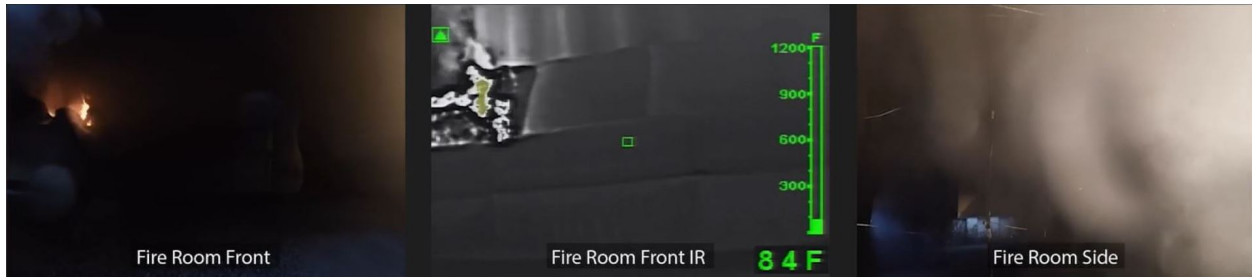
Figure 5.19: Experiment 4 - Conditions in the fire room at 165 s, 30 s after nozzle activation.

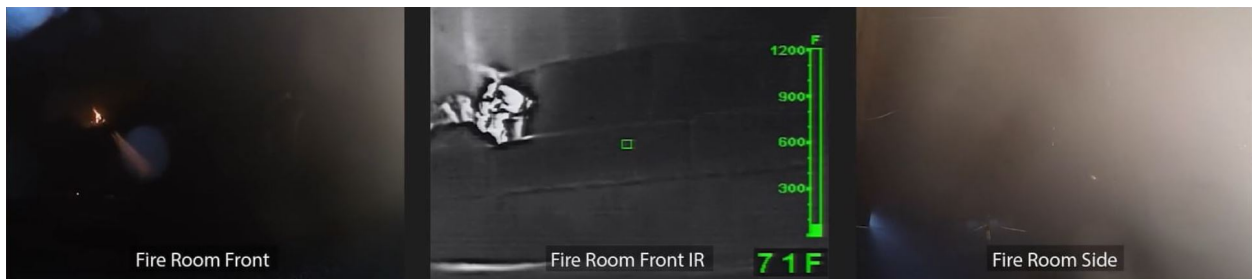
Figure 5.20: Experiment 4 - Conditions in the fire room at 736 s, 10 minutes after nozzle activation.

shielded from the water spray. Temperatures throughout the structure dropped beneath 30 °C by 189 seconds after the nozzle activated. The peak temperature during the experiment was approximately 120 °C which was measured at Position 1, 2.54 cm (1 in) from the ceiling. The peak heat flux measured in the fire room was 3 kW/m². The O₂ concentration measured 1.5 m (5 ft) above the floor in the fire room decreased slightly during the fire growth, but returned to ambient shortly after nozzle activation. The remaining gas concentrations did not show much response during the experiment. Water flow was turned off after 10 minutes, after which the fire slowly recovered. About six minutes after the water was turned off the window to the fire room was opened and hose suppression was applied. Immediately prior to opening the window, the peak temperature in the structure was 50 °C, measured 2.54 cm (1 in) from the ceiling at Position 1. Throughout the whole experiment, the entire structure met UL 1626 criteria for tenability. Visual conditions in the fire room, from just before water began to flow from the nozzle through 10 minutes after the nozzle activation, are shown in Figures 5.18, 5.19, and 5.20. After the water flow was turned off, a small amount of flame was visible on the left side of sofa as shown in Figure 5.20.

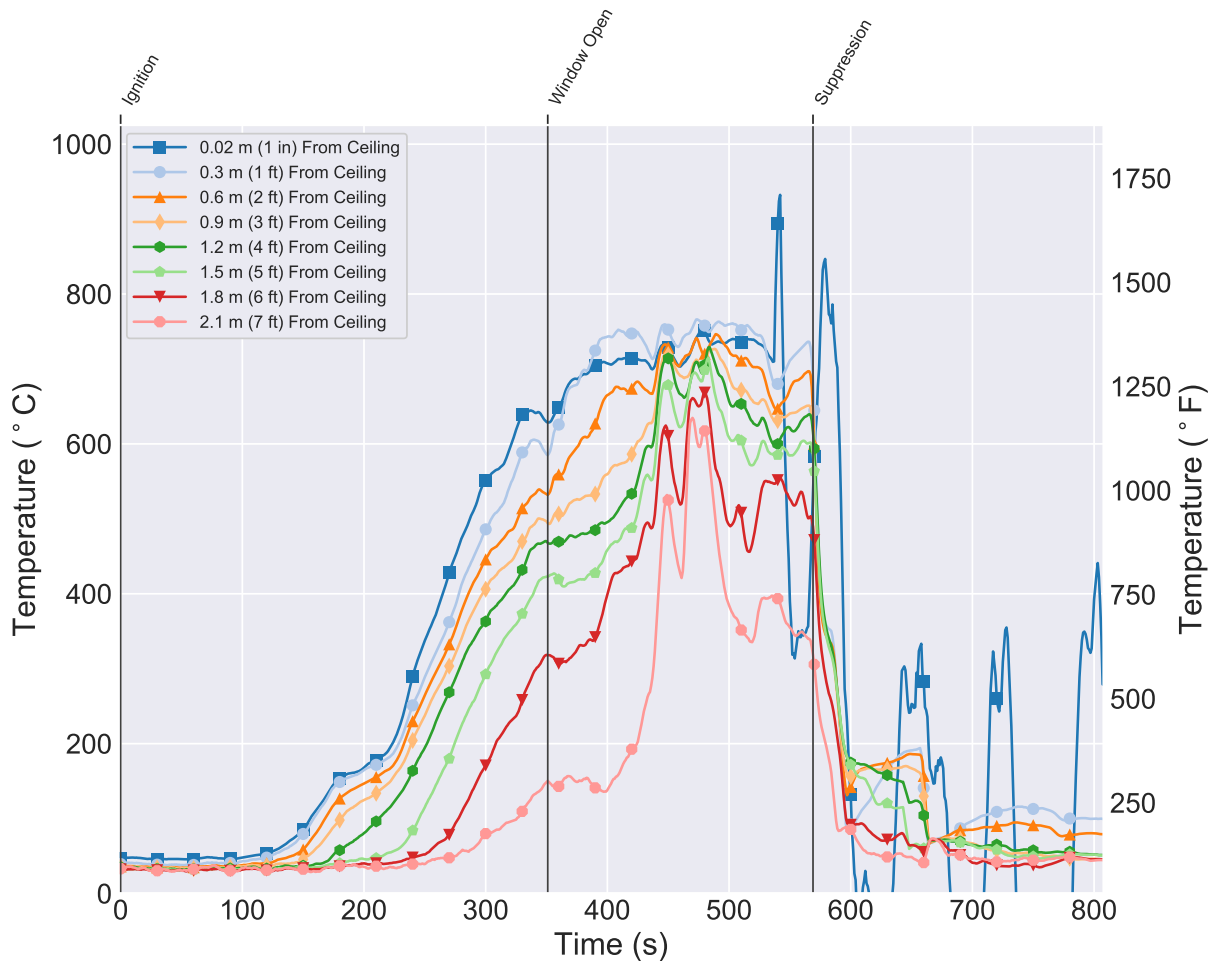
Figure 5.21: Experiment 6 - Thermocouple temperature time history from the thermocouple array in the fire room (Position 1).

were observed in the fire room. All of the temperatures measured by the thermocouple array in the fire room exceeded 600 °C at 466 seconds after ignition. The peak heat flux measured in the fire room was 50 kW/m², which occurred 393 seconds after ignition. The gas concentrations measured in the fire room showed similar response profiles as the temperatures in terms of increased hazard to human life. Hose-line suppression took place 570 seconds after ignition.

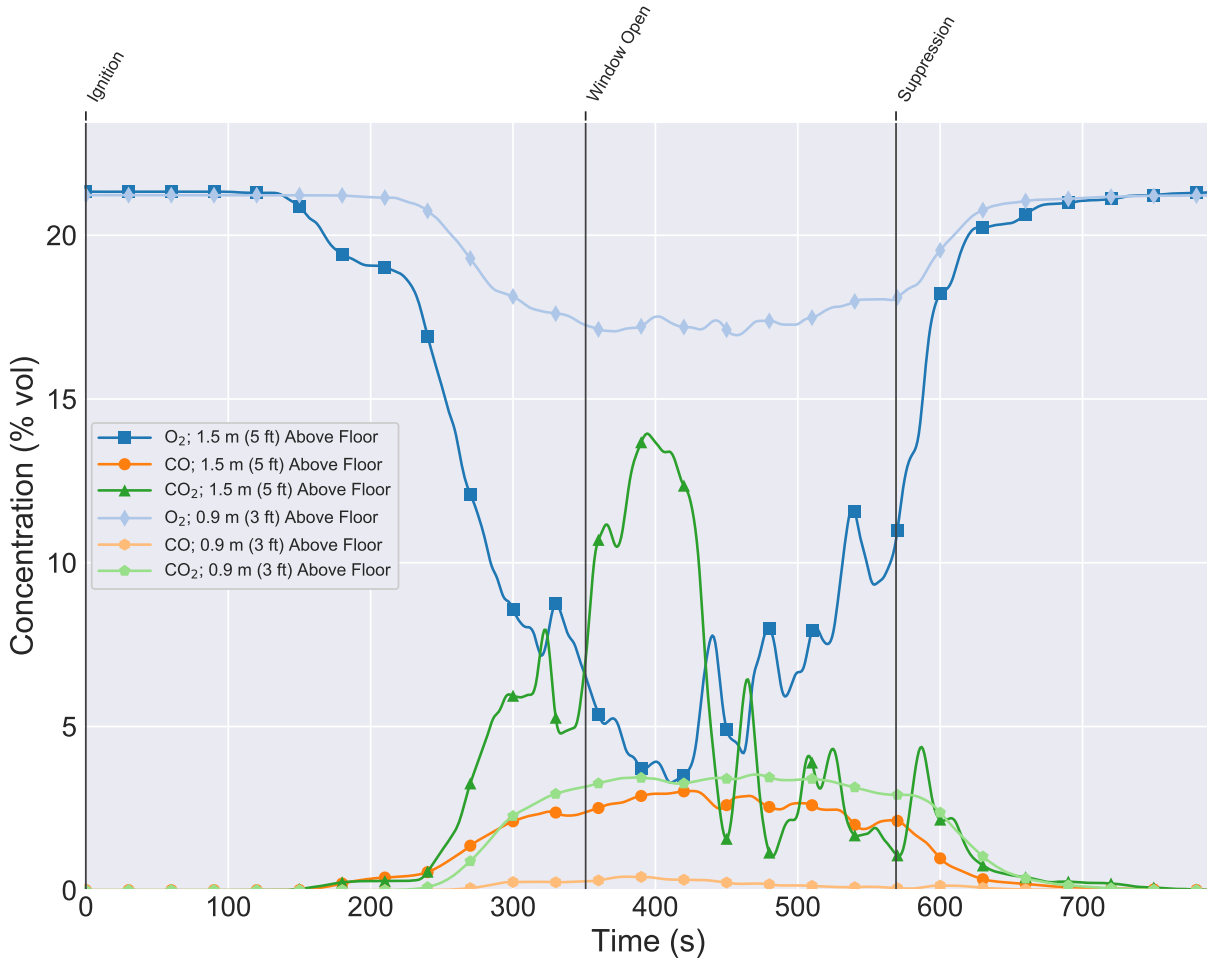
Figure 5.22: Experiment 6 - Gas concentrations time history measured in the fire room (Position 1).

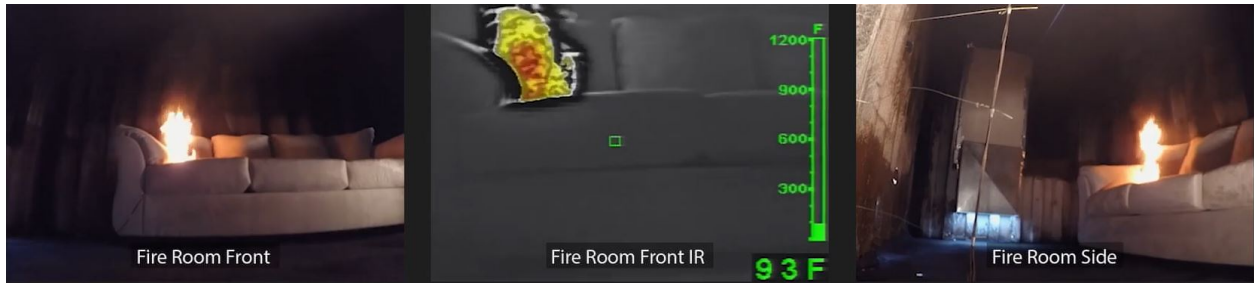
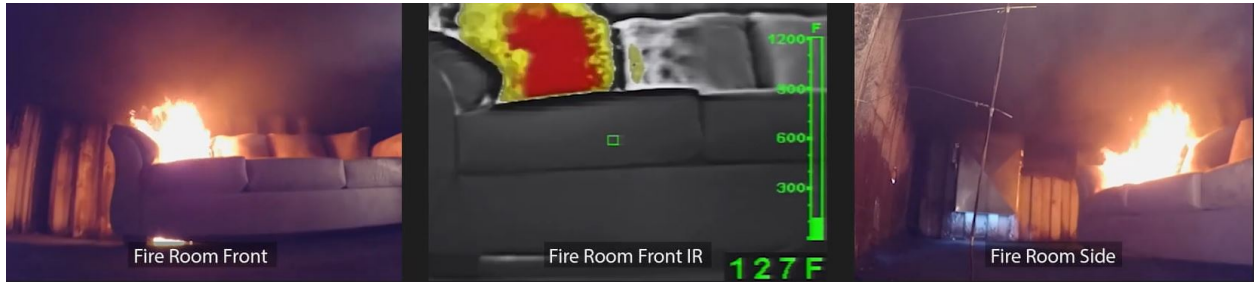
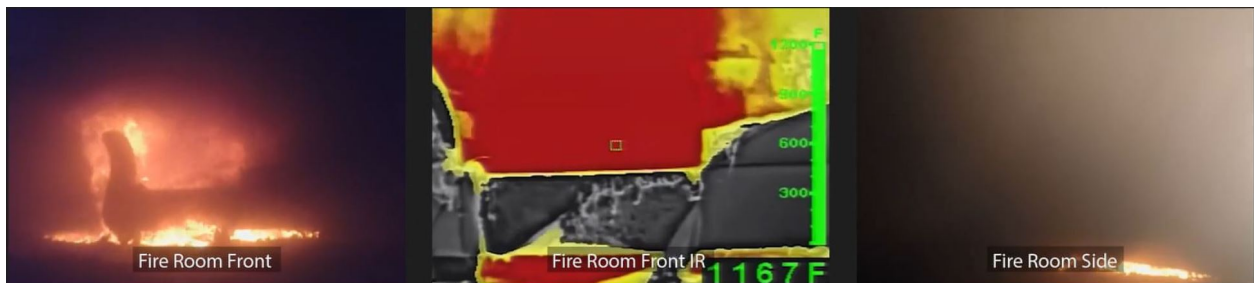
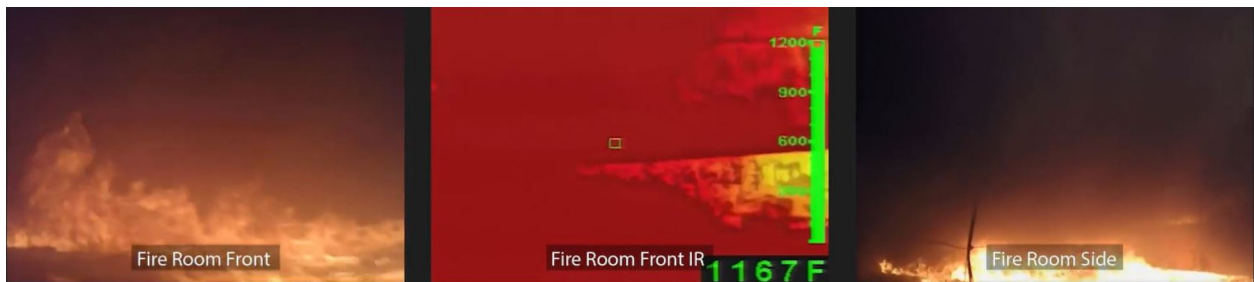
Figure 5.23: Experiment 6 - Conditions in the fire room at 120 s after ignition.

Figure 5.24: Experiment 6 - Conditions in the fire room at 180 s after ignition.

Figure 5.25: Experiment 6 - Conditions in the fire room at 300 s after ignition.

Figure 5.26: Experiment 6 - Conditions in the fire room at 420 s after ignition.

Figures 5.23 through 5.26 present images recorded from video and thermal imaging cameras that were located in the fire room. The first two figures, Figures 5.23 and 5.24, provide an indication of the size of the fire for a time period, 120 s to 180 s, that bounds the fire suppression system activation times in Experiments 1 through 5. Figures 5.25 and 5.26 show the fire growth in 2 minute intervals after the time when in the previous experiments fire suppression would have started due to water spray from a sprinkler or a nozzle. Figure 5.25 shows the fire while it is still in the growth stage. Figure 5.26 has images that were recorded after the opening the window vent, which would be more representative of a fully developed fire stage. The difference between these two figures is evidence that even with the limited fuel load the fire was burning in ventilation limited or fuel rich condition and the addition of oxygen increased the fire hazard.

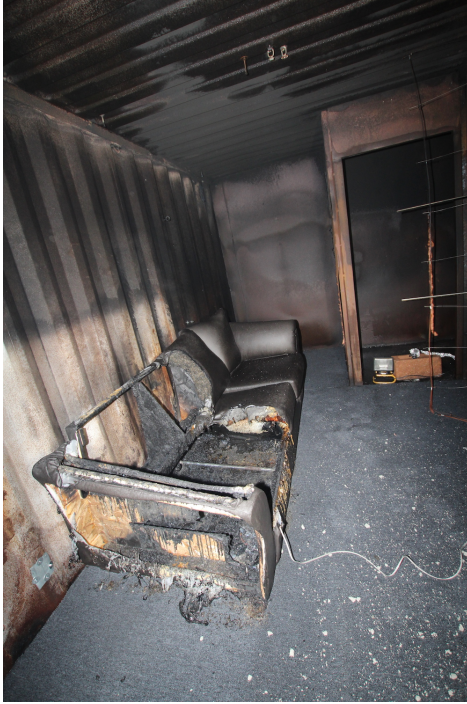
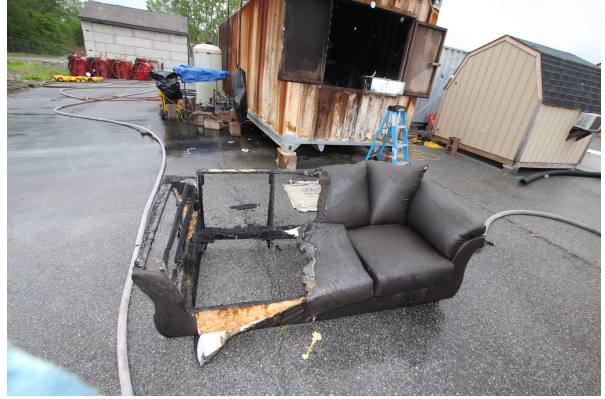
Figure 5.27: Photographs of the fire damage to the sofa from Experiment 1.

Figure 5.27 shows post test photos of the sofa from Experiment 1. The foam and fabric from approximately the entire left half of the sofa were consumed, with the right half of the sofa left intact. Some of the damage to the sofa occurred during the 5 minute period after the sprinkler was turned off, and before the experiment was concluded. Although this damage reflects the failure of the sprinkler to extinguish the fire, the duration of the burning after deactivating the sprinkler was arbitrary. Therefore comparisons between experiments based on post-fire damage are limited.

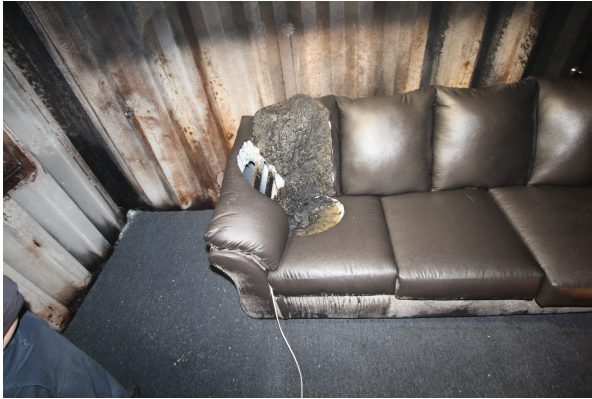
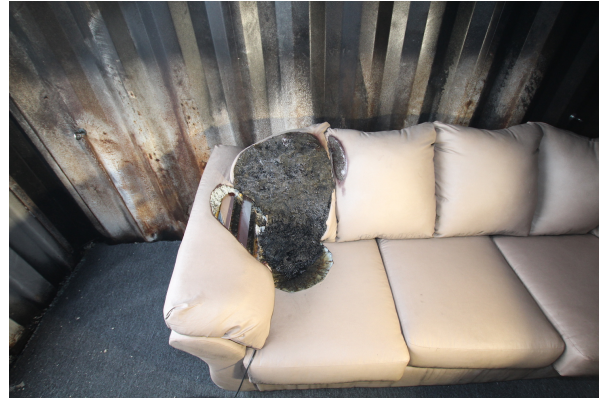
(a) Experiment 2

(b) Experiment 5

Experiment 3 showed that there exists a large difference in performance between flow rates of 11 lpm (3 gpm) and 23 lpm (6 gpm) for the medium capacity nozzle. For equivalent fire scenarios, the nozzle flowing at 11 lpm (3 gpm) in Experiment 3 failed to suppress the fire, but the nozzle

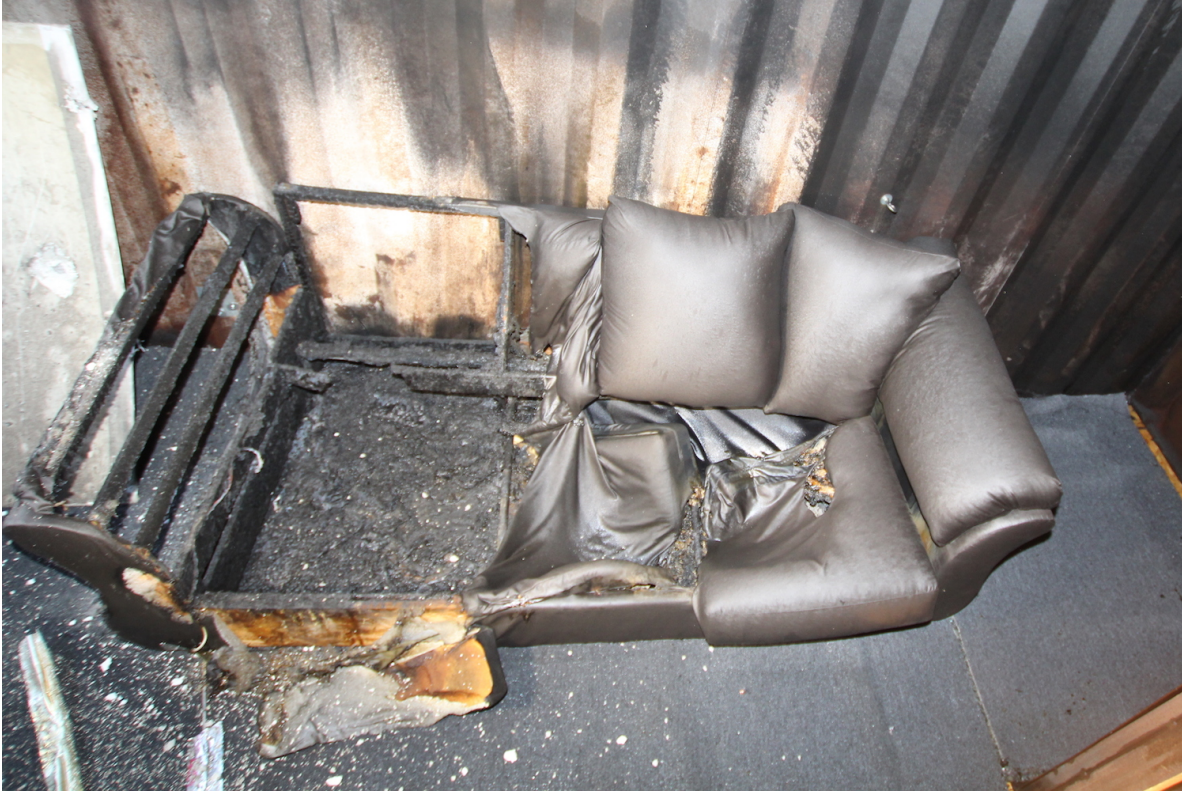
Figure 5.29: Photograph of the fire damage to the sofa from Experiment 3.

Figure 5.29 shows the fire damage to the sofa in Experiment 3. The foam and fabric on the left half of the sofa was entirely consumed, with further damage evident on the right side. The damage extending into the right side of the sofa is indicative of melting and pyrolysis due to the radiation from the fire, and occurred ahead of the flame spread. In contrast, the damage to the sofa in Experiment 1 (Figure 5.27) showed little to no damage on the right side of the sofa, despite the entire left side being consumed. This difference is due to the sprinkler's ability to pre-wet the surfaces of the fuel in Experiment 1, whereas the nozzle in Experiment 3 was insufficient to deter fire growth in the same way. The damage in Experiment 3 is greater than in any of the other experiments, excluding the free burn (Exp. 6).

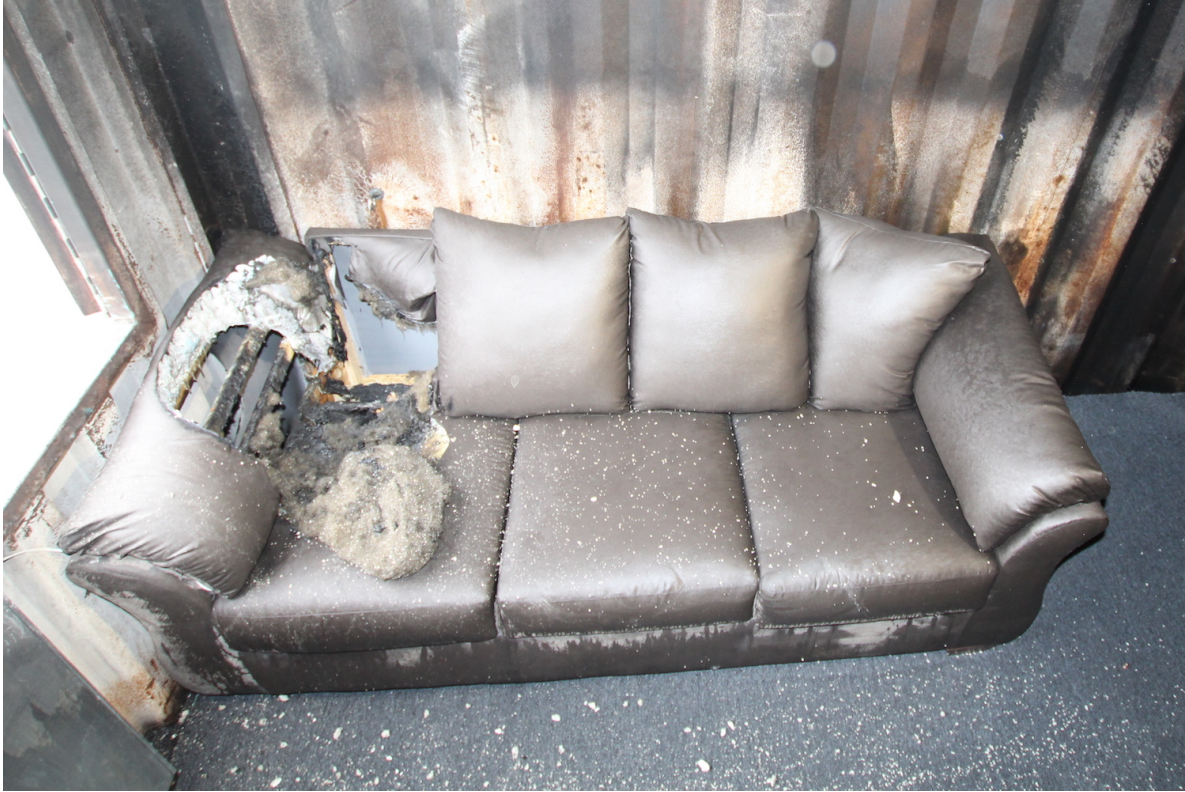
Figure 5.30: Photograph of the fire damage to the sofa from Experiment 4.

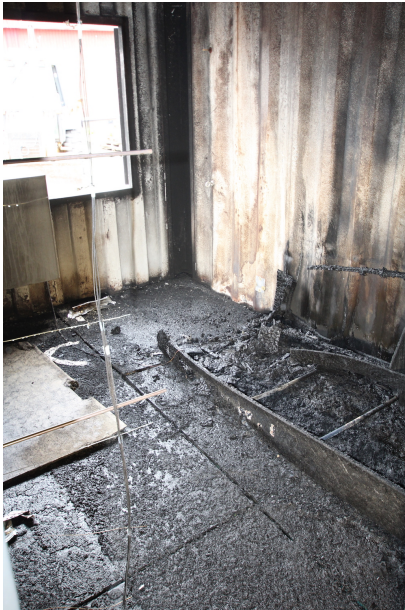
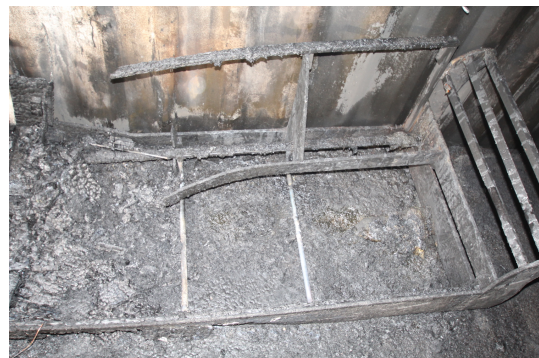
Figure 5.31: Photographs of the fire damage to the sofa from Experiment 6.

In Experiment 6 there was no water spray system used, and the fire room reached flashover. Figure 5.31 shows a photo of the remains of the sofa. The synthetic components of the sofa (foams

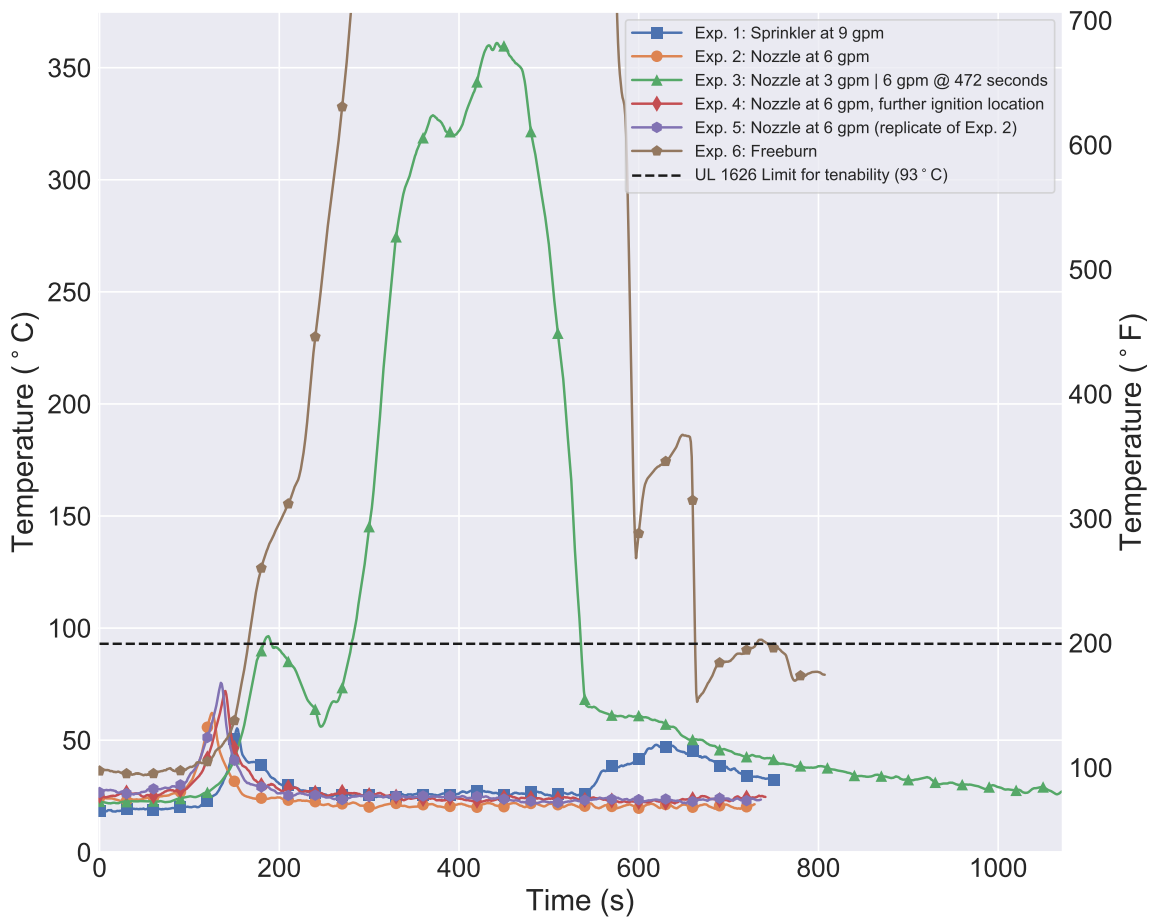
Figure 5.32: Comparison between furnished room experiments of the temperature time history (from ignition until the water spray was deactivated) measured at 1.8 m (5.8 ft) above the floor in the fire room. The UL 1626 limit for tenability – 93°C measured 1.6 m (5.25 ft) above the floor – is included for reference.
